PINELAKE APARTMENTS

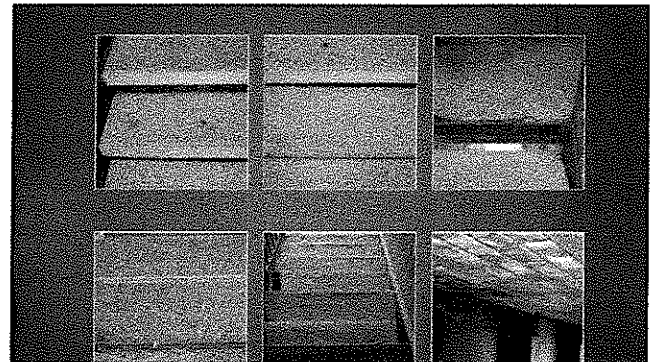
- Railings on the stairs are painted green all the way up. Much of the railing is showing signs of rust and deterioration. There are no railings on the stairs with missing or broken anchoring hardware. The entire railing along the parking lot of the Pinehurst is a state of disrepair and has been over the wall for many years. The railing appears to have been broken and approximately 40 feet of the railing has been removed.
- The wooden railings at the top of the stairs look like they have been painted and are in good condition.

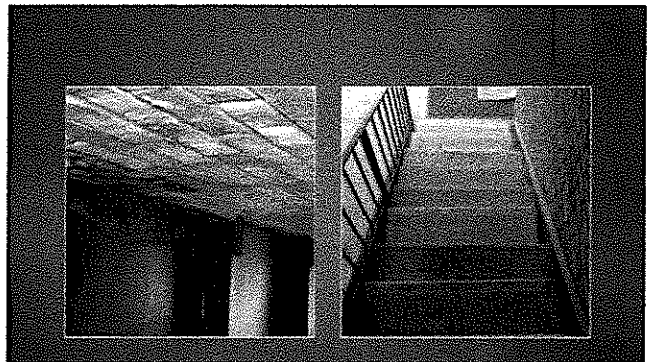
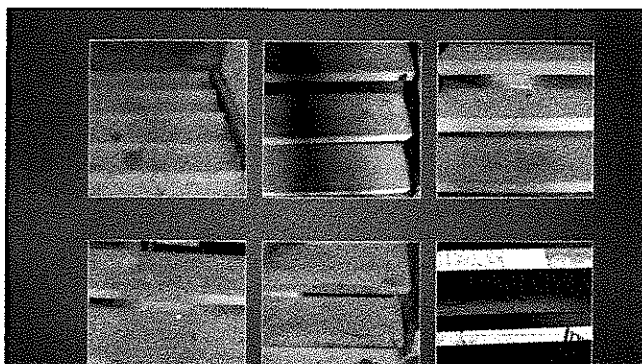
- The steps and landings of the breezeway have several issues. These breezeways are the only means of access for both the 2nd and 3rd floors. The heads of the steps are uneven and are not a consistent depth from top to bottom. The use of the steps varies significantly from one step to the next and presents a liability. The left side of signs of cracking and deterioration. There are also areas of spalling and large chunks of concrete are missing from the steps.

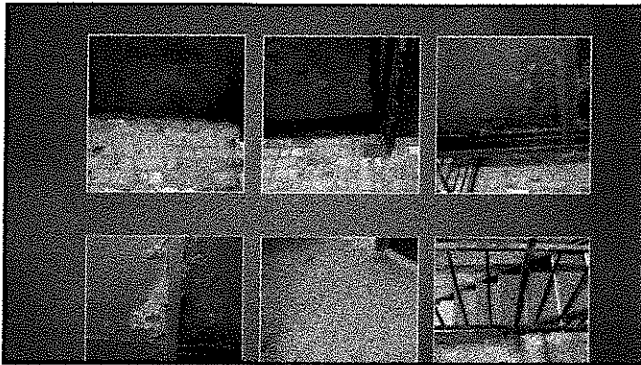
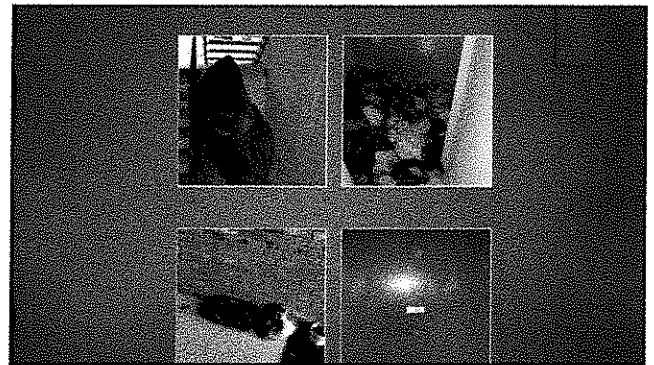
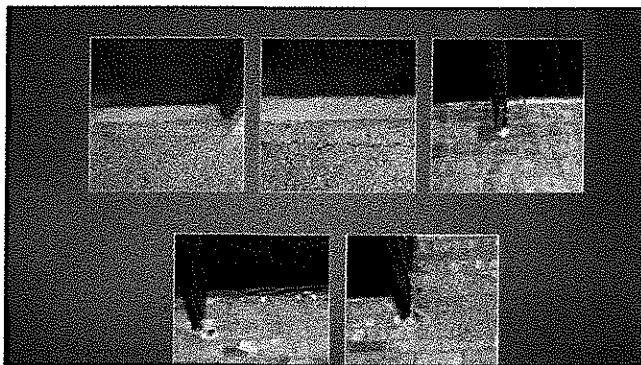
- The landings are comprised of concrete poured in a pan that is supported on the underside by metal beams. These beams are then supported by metal rods inserted in the back of the wall. The concrete shows spalling across the entire surface of the landing. There are also significant cracks and chipping of the concrete itself. Both the beams and concrete pan show significant areas of rust and holes. There are many areas of bulging paint indicating further deterioration of the metal of the pan. There is also a crack and mortar material around the support rods inserted into the brick. There are areas where this deterioration of the brick has had attempts to repair.

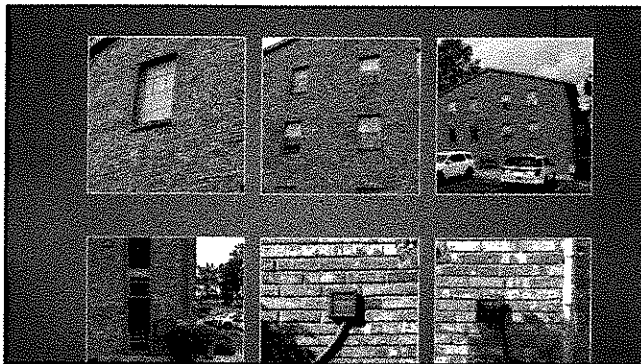
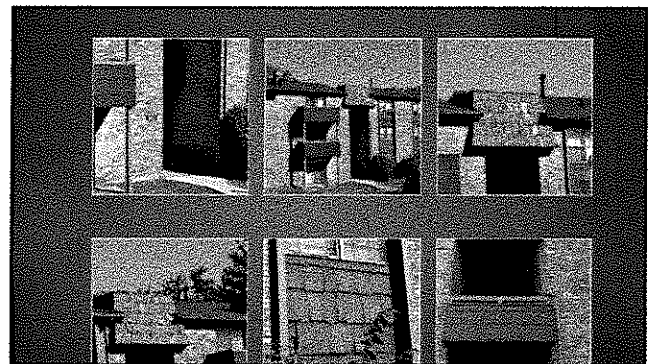
- Siding and trim on the buildings show significant signs of deterioration. The siding consists of wood shingles painted blue. These shingles cover the sides of the roof directly above the breezeways and also are directly below windows. The siding is in need of paint and shows significant signs of fading or lacking no paint at all. There are multiple areas where the siding is missing, has rotted away leaving holes and gaps.

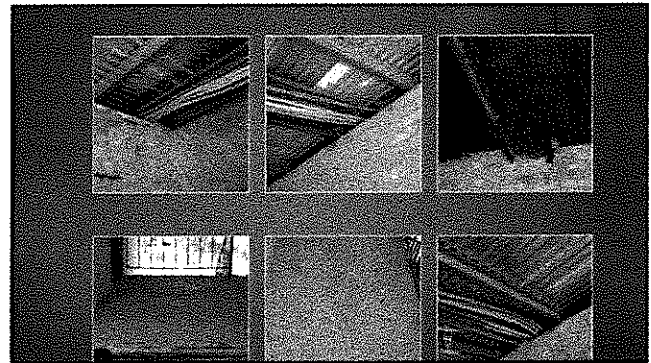
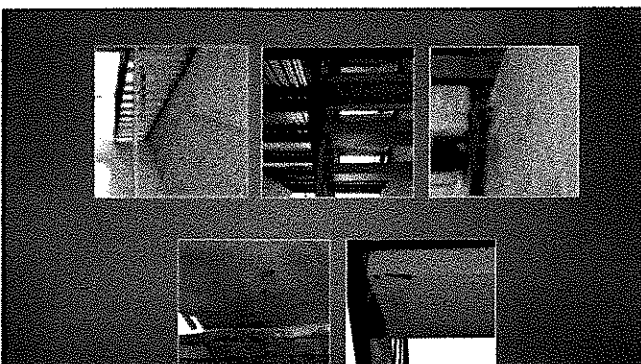
- The steps and landings of the breezeway have several issues. These breezeway are the only means of egress for both the 2nd and 3rd floor. The treads of the steps are uneven and are not a constant depth from top to bottom. The rise of the steps varies significantly from one step to the next and presents a fall hazard. The steps show signs of cracking and deterioration. There are areas of spalling and large chunks of concrete are missing from the steps. The stringer on the bottom floor appears to be supported by a purchased wood.

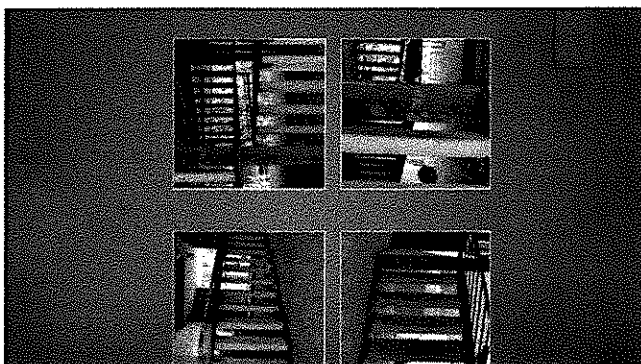
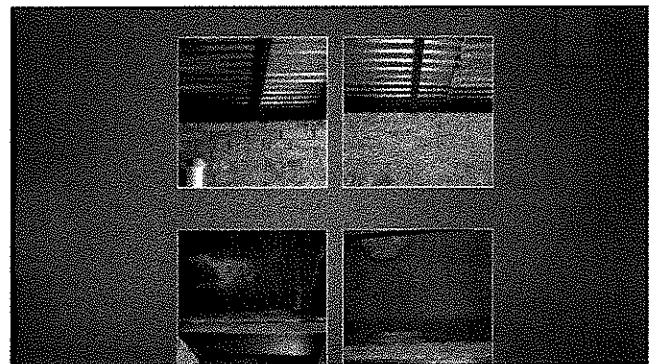
- The landings are composed of concrete poured in place but is supported on the underside by metal beams. These beams are then supported by metal pins welded to the back of the walls. The concrete shows staining, cracking, and other signs of deterioration. There are also signs of cracking and spalling of the concrete floor. Both the beams and concrete pins show significant rust and deterioration. There are many areas of buckling and metal fatigue. Deterioration of the metal and pins. There is a lot of rust and metal fatigue around the support pins welded into the walls. There are areas where the deterioration of the metal has had attempts to repair.
- Work to replace the second floor landing is complete. Another issue was found with the entire landing. The work is under a permit which has not been fully inspected and allowed with the Boone County Building Department.

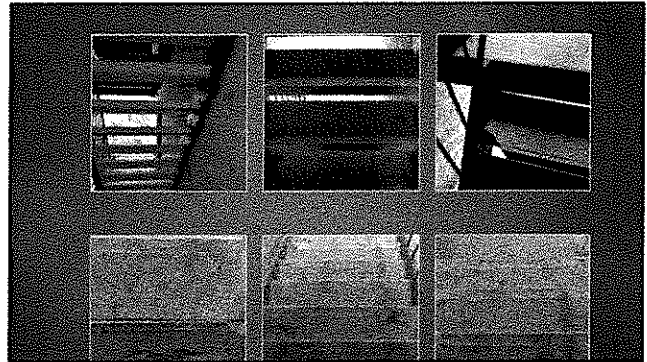
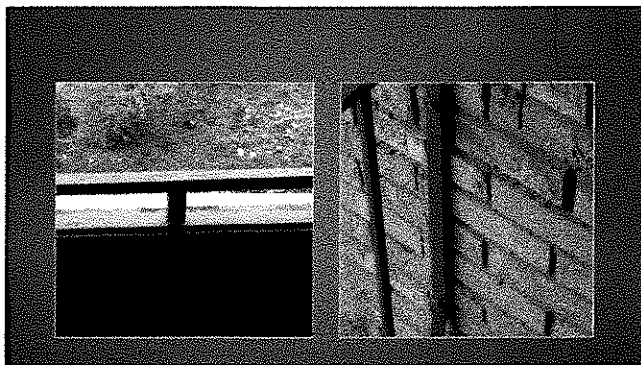
- Railings are looking in paint almost all locations. Much of the railings are showing signs of rust and deterioration. There are areas of the railings with missing, broken or loose anchoring hardware. The wooden railing at the landing of the steps looks paint has areas of mold and rot.

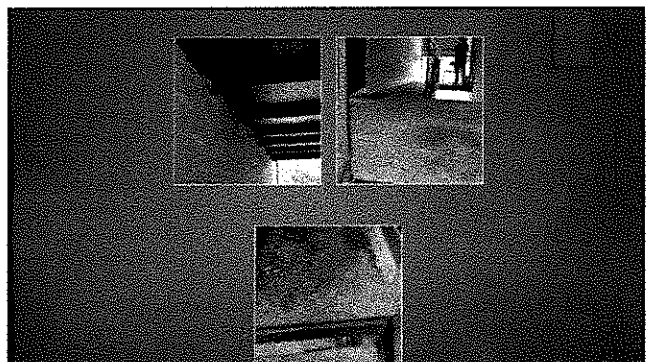
- The landings are comprised of concrete poured in a pan that is supported on the underside by metal joists. These beams are then supported by masonry inserted in the back of the wall. The concrete shows spalling across the entire surface of the landing. There are also significant cracks and a lining of the concrete itself. Both the bottom and concrete parts show signs of rust and holes. There are many areas of bubbling paint indicating further deterioration of the finish of the paint. There is a loss of brick and mortar masonry around the support posts inserted into the brick. There are areas where this deterioration of the brick has had attempts to repair.

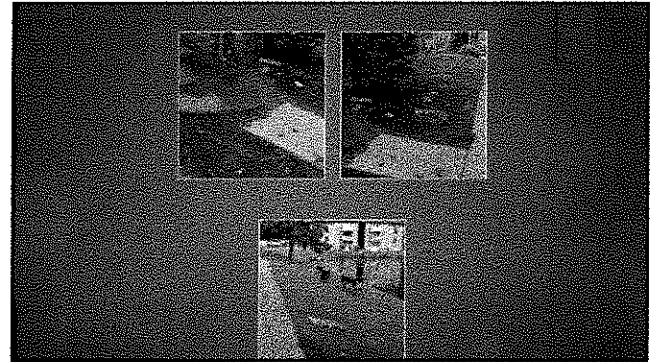
- There is trash throughout the area by the table and overflowing garbage cans.

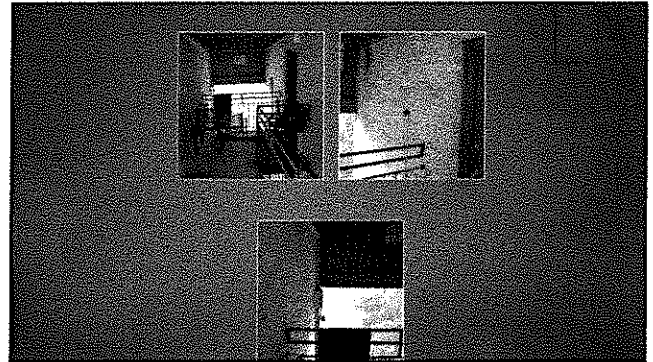
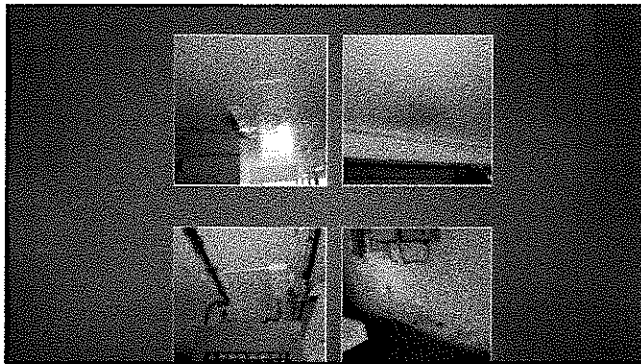
- The duct closer to the laundry room is rotten. There is standing water on the floor. There are areas of plastic and mildew throughout the room. There are holes and leaks from the ceiling. The venting of the heating system is displaced.

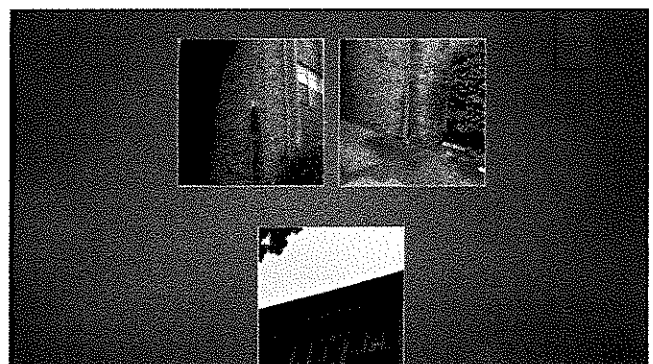
- » There are open flame devices being stored and/or used on the 3rd floor landing. Furniture is also being stored on the landing.

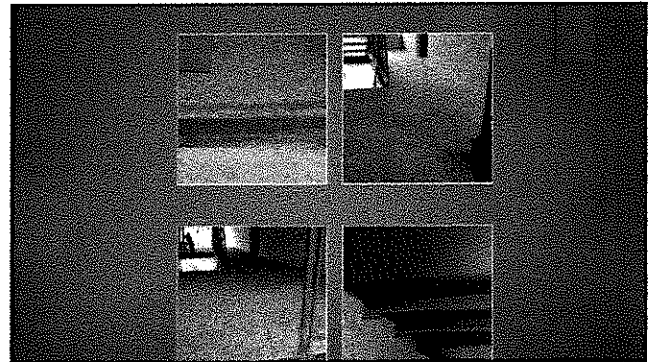
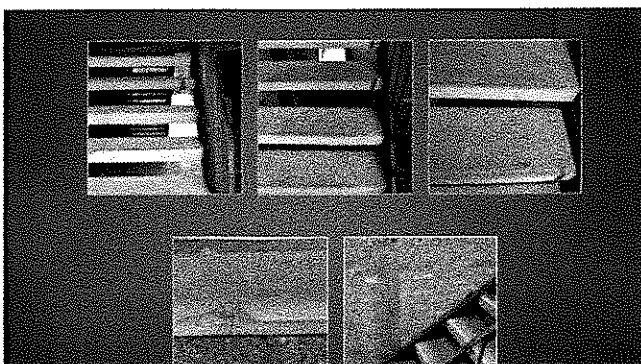
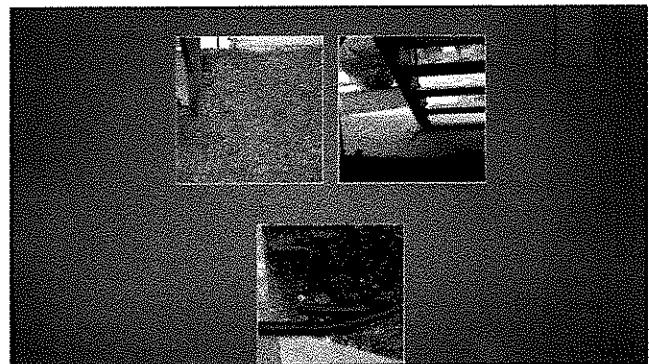
- The steps and landings of the breezeway have several issues. These breezeways are the only means of egress for both the 1st and 2nd floors. The tread of the steps are uneven and are not a consistent depth from top to bottom. The rise of the steps varies significantly from one step to the next and presents a fall hazard. The steps show signs of cracking and deterioration. There are areas of spalling and large chunks of concrete are missing from the steps.

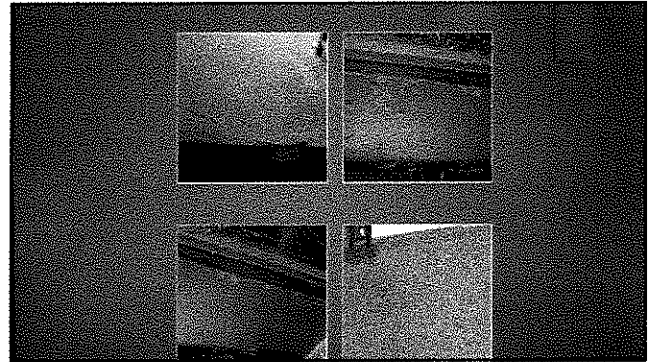
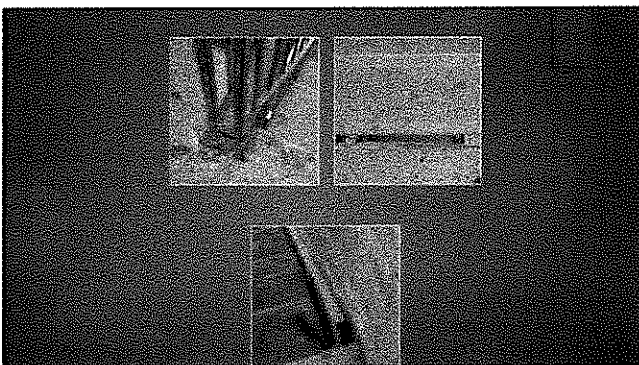
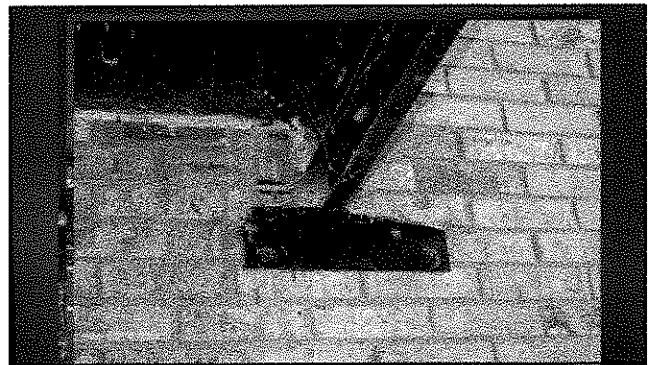
- The steps and landings of the breezeway have several issues. These breezeways are the only means of egress for both the 2nd and 3rd floor. The heads of the steps are uneven and are not a consistent depth from top to bottom. The rise of the steps varies significantly from one step to the next and presents a fall hazard. The steps show signs of cracking and deterioration. There are areas of spalling and large chunks of concrete are missing from the steps.

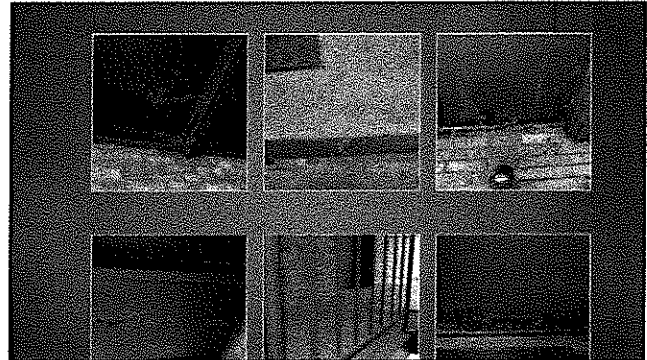
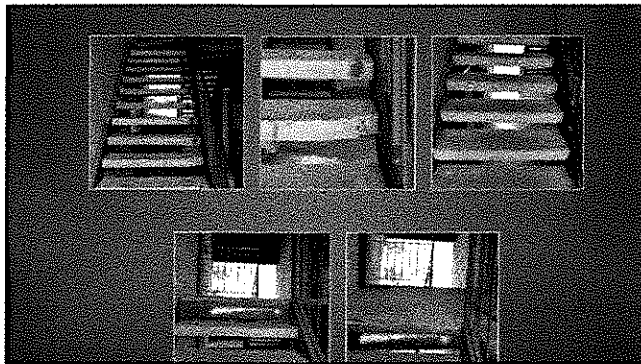
- The steps and landings of the breezeway have several issues. These breezeways are the only means of egress for both the 2nd and 3rd floors. The treads of the steps are uneven and are not a consistent depth from top to bottom. The rise of the steps varies significantly from one step to the next and presents a fall hazard. The steps show signs of cracking and deterioration. There are areas of spalling and large chunks of concrete are missing from the steps.

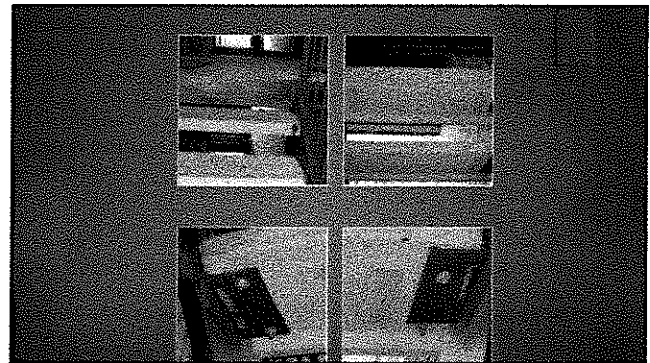
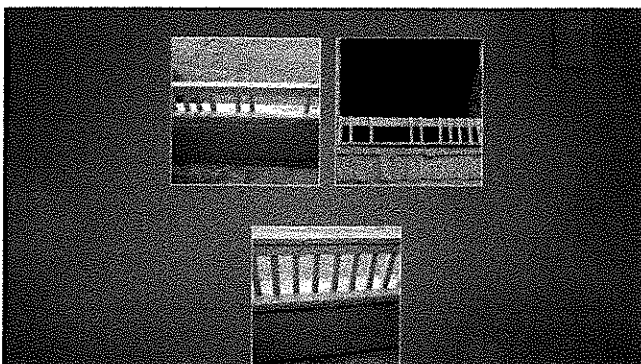
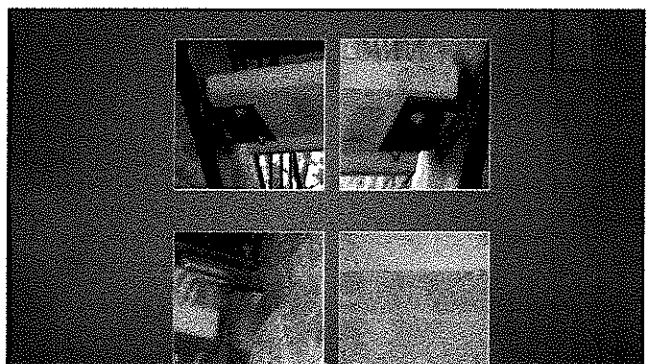
- Railings are lacking in paint and at locations. Much of the railings are showing signs of rust and deterioration. There are gaps in the railings with missing balusters or loose attaching hardware. The wooden railing at the landing of the steep breezeway has areas of mold and rot.

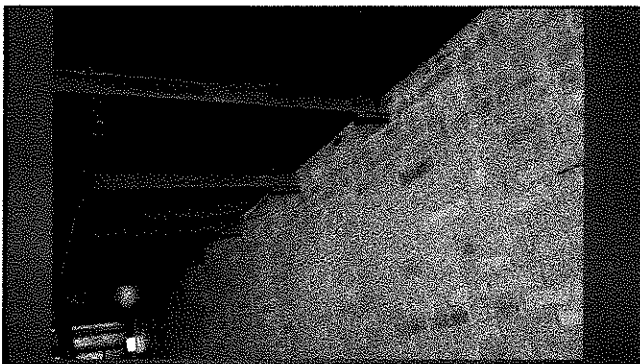
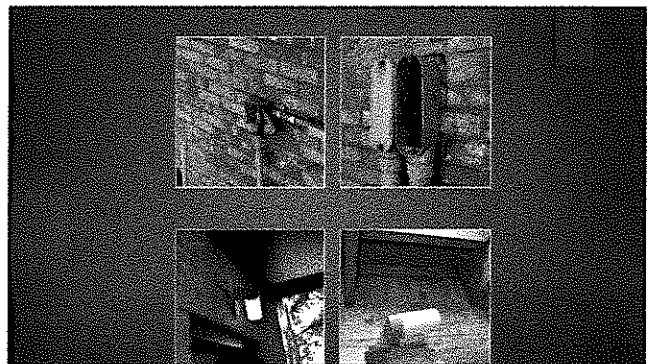
- There is exposed wiring and outlet boxes from light fixtures that are in disrepair. There are exposed service wires in broken conduit. There are exposed wires in junction boxes.

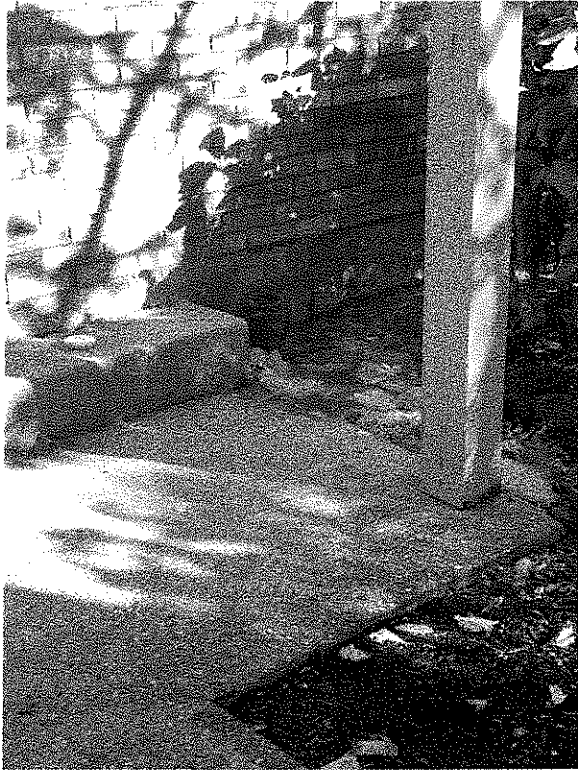
Sanitary Drainage	PM 506.2 (O-11-03)	Comply By 17 days	Applied on Oct 18, 2021 by Mike Macaluso	Closed on Oct 26, 2021 by Mike Macaluso	Closed, compliant, Voluntary
Every plumbing stack, vent, waste and sewer line shall function properly and be kept free from obstructions, leaks and defects.

Pipe and area has been fixed and cleaned, no more violation at this time
