# **EXHIBIT B**

1. December 17, 2021 Status Update with Photographs
2. December 23, 2021 Status Update with Attachments
3. Cole Engineering Report
4. January 2022 Status Update

**RE: Pine Lake Apartments Status Update**

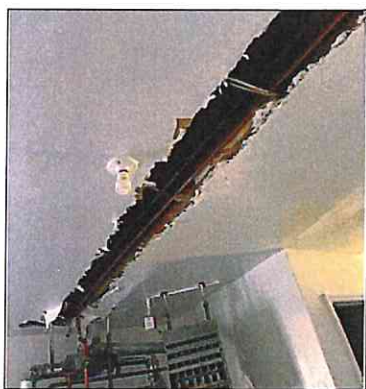
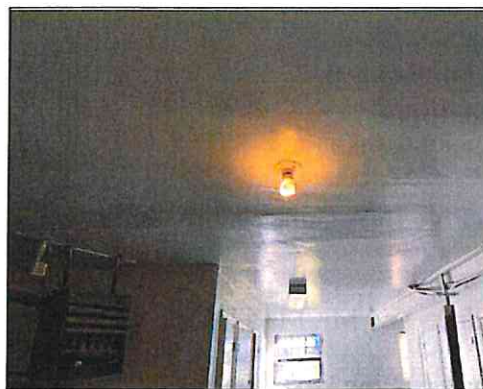
During the December 6, 2021 inspection, it was our understanding that the laundry and storage room walls were satisfactory with two limited exceptions. Those two areas that required additional drywall repairs have now been fixed.

[The above photographs show the repairs that were made at 7141 Spruce.]

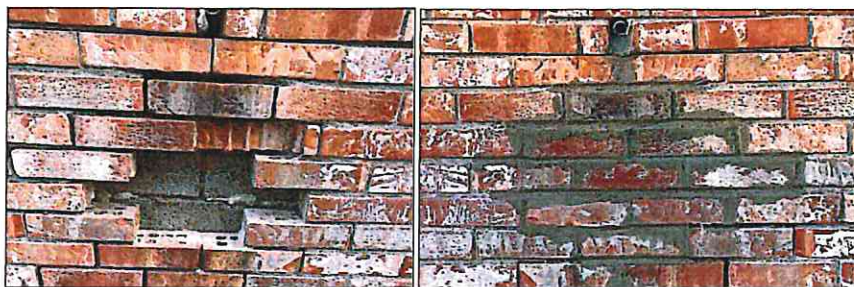
110 Pinehurst: The exterior wall has a large section of brick missing on the first floor.

Additionally, the brick facade at 110 Pinehurst has now also been repaired.

Pine Lake will continue to monitor drywall and brick facades to ensure any new issues are timely repaired.

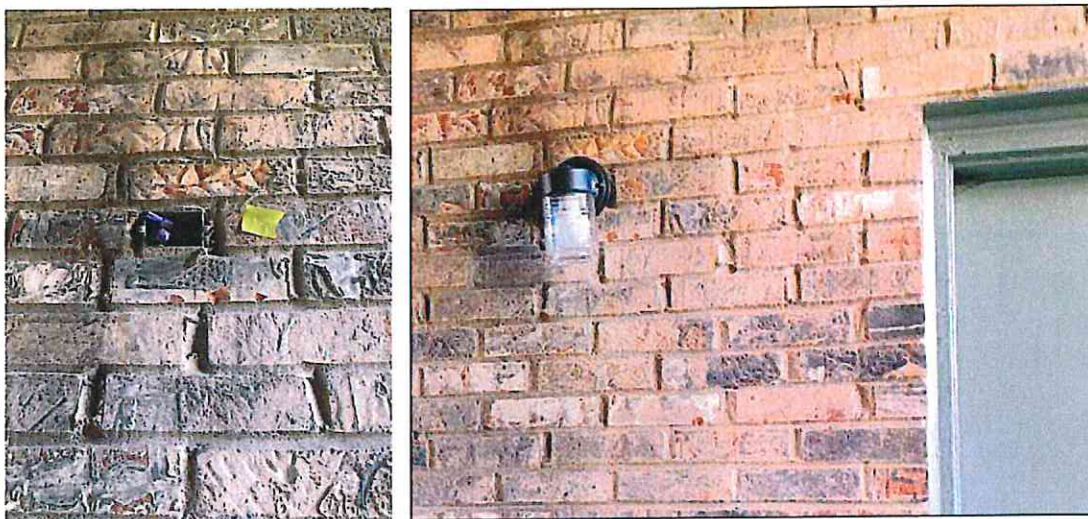
**Notes:** Open and spliced wiring is found throughout the complex at the light fixtures, outlet boxes, heating devices, timers, outlet boxes and conduit.

Pine Lake replaced many of the exterior lights prior to the December 6, 2021 re-inspection as noted in the report. Additionally, those areas identified during the inspection have also been repaired including for example the missing light fixture shown below.

[The above picture also shows the exterior doors which have all been repainted.]

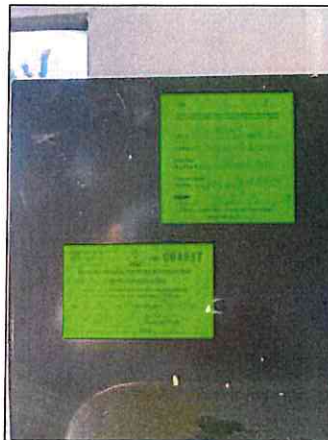
Is wiring properly installed and protected?  
Wiring shall be installed per electrical code and protected from damage, 2012 NFPA 1 11.1.3  
**Status: FAIL**  
**Notes:** 101 Pinehurst: Wiring conduit is installed through the dryer vent.  
12/6/2021 An electrician has informed the property owner that this condition meets current electrical code. This remain in violation pending documentation from the electrician.

The area identified at 101 Pinehurst has been reviewed by a licensed electrician who has determined that the conduit is not installed through the dryer vent. Instead, the conduit exits the building next to the dryer vent. Additionally, there is no live electrical wiring contained within the conduit. Instead, the conduit contains a ground wire that was installed pursuant to applicable codes. Below are inspection stickers reflecting inspections previously performed at this location.

For these reasons, we respectfully request this item be removed from the report.

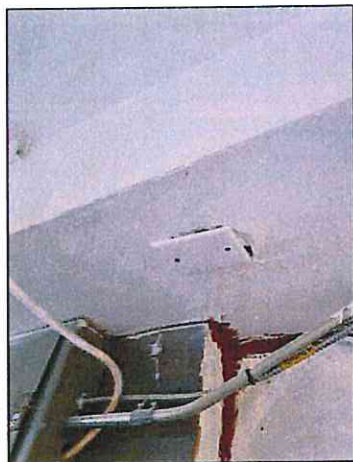
Are covers in place for junction boxes, outlets, and breaker/fuse panels?  
Install covers on any open junction boxes, outlets, or breaker/fuse panels. 2012 NFPA 1 11.1.2  
**Status: FAIL**  
**Notes:** Outlet boxes are missing covers and/or replacement light fixtures.  
12/6/2021 This condition still exists in locations. Light fixtures still have exposed wiring and and in a state of disrepair in multiple locations.

Once again, light fixtures have been replaced throughout the property. There were a small number of locations where covers were replaced at junction boxes. Below shows one example that was repaired.

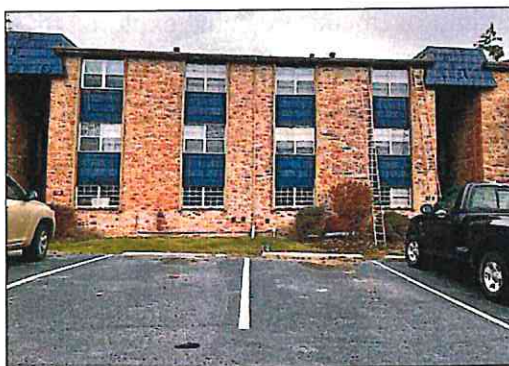
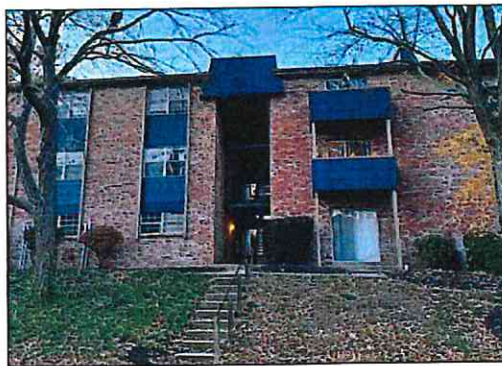
Siding throughout the complex is in poor condition. Shingles are missing, holes and rot are evident.  
12/6/2021 No change in these conditions.

As of the December 6, 2021 inspection, Pine Lake had repainted shingles above breezeways. As a result, we disagree with the statement that there has been no change. Nonetheless, Pine Lake will continue to repair siding throughout the property as needed.

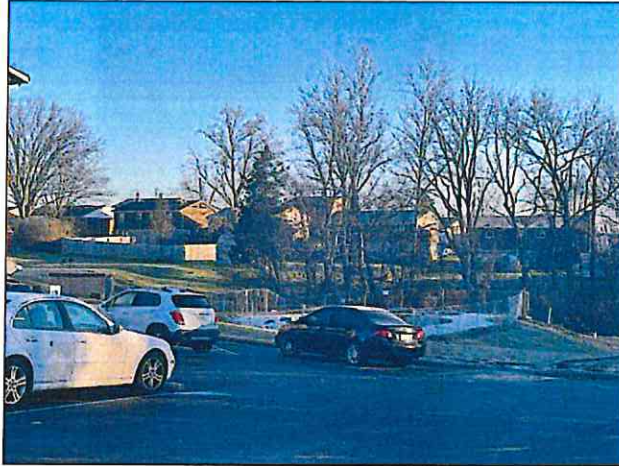
Pine Lake has also removed the structures adjacent to the pool which also eliminates concerns regarding the condition of the siding on those two buildings.

[Photograph of pool area with pump house removed]

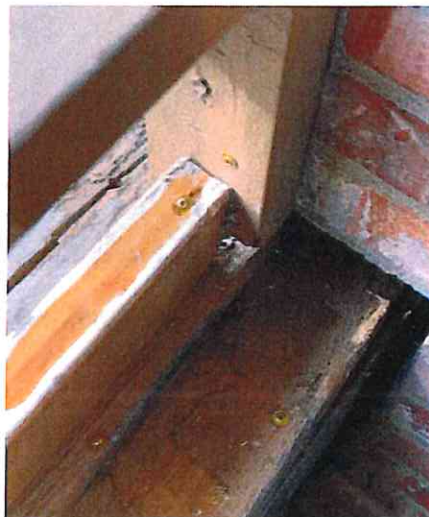
Railings through out the complex are in poor conditions. Wood rails are in need of paint, show signs of rot and holes  
12/6/2021 No change in these condition

Wood railings have been resecured with appropriate fasteners. The below photograph shows one such railing. These areas are also scheduled to be painted as soon as possible, weather permitting. Please note that more substantial capital improvements are being explored to partially enclose the breezeways which would eliminate these wood railings.

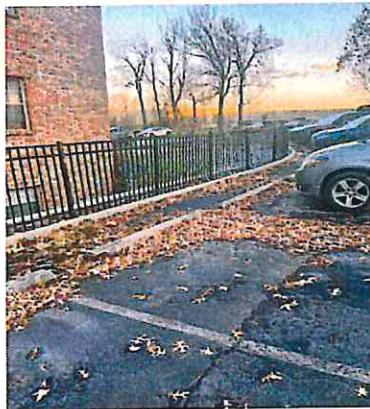
The fencing at the parking lot has also been replaced as depicted below.

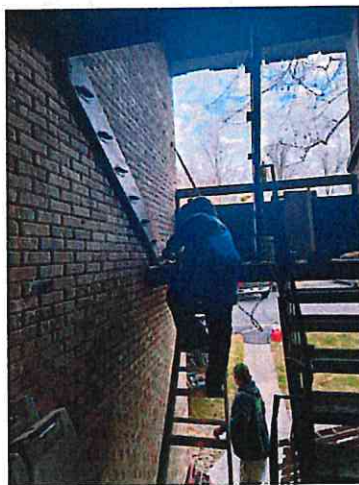
Steps throughout the complex are in poor condition or have been installed contrary to the building code. Tread depth varies from step to step, rise height varies from step to step; anchoring of the steps have signs of instability; steps themselves are cracked and missing large portions  
12/6/2021 No change in these condition

Pine Lake is continuing to make repairs to the concrete steps that are deteriorating as shown in the photograph below (taken on December 11, 2021).

However, Pine Lake disagrees with the inspection reports conclusion that replaced steps are in not in accordance with code requirements. To date, Pine Lake has engaged Custom Concrete to

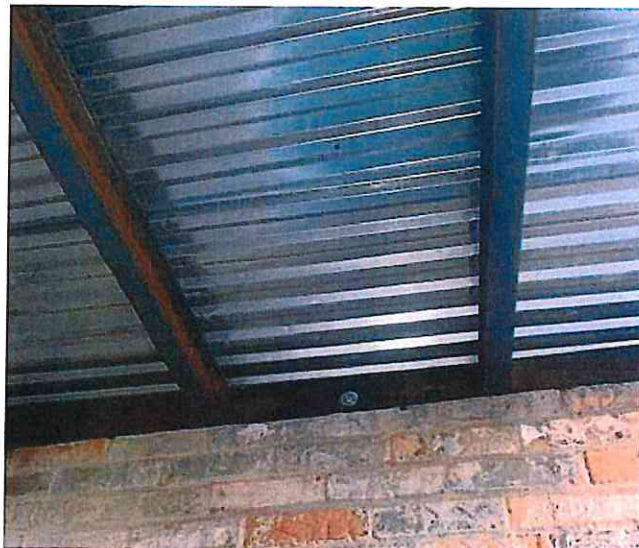
Landings are in poor condition. The landing surface has spalling across the entire surface; the support pans are rusted and have bubbling paint; support i-beams are rusted; support anchors in brick are showing signs of deterioration and instability  
12/6/2021: No change in these condition

Pine Lake disagrees with the statement that there has been no change in this condition. All second floor landings, in need of repair, were permitted and repaired by Custom Concrete. There was one landing where anchor bolts were identified as missing on December 6, 2021. Those anchor bolts have now been installed.

Cole Engineering inspected the remaining landings on or about December 13, 2021. They are preparing a report to determine the structural integrity of the landings and propose repairs as

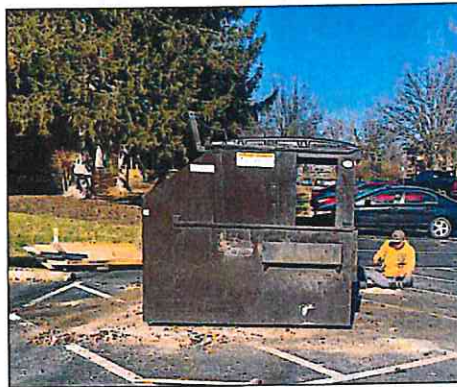
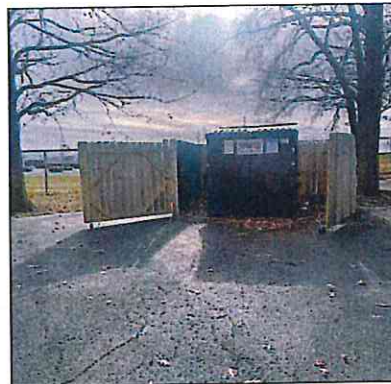
This item continues to be monitored to ensure trash accumulation does not occur. Due to ongoing renovations at the property, it is necessary to continue to utilize the 30 yard dumpster at the upper parking lot.

Furthermore, all dumpster enclosures have been reduced to their original sizes and the dumpster enclosures, not previously approved through zoning, near building 118 has been completely removed.

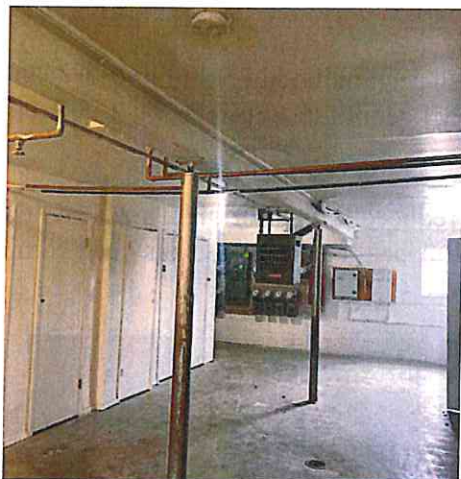
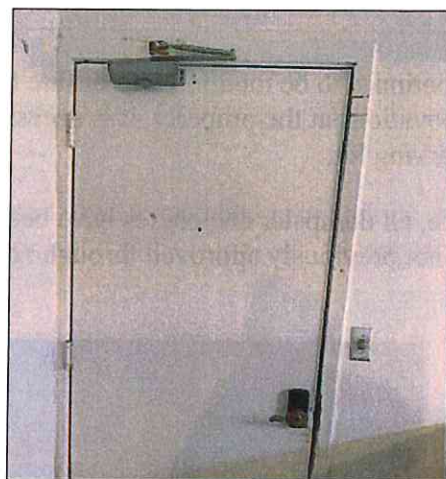
Black mold and mildew are found in areas of multiple laundry rooms. Leaking pipes and drains are also found across all laundry rooms. (Corrected 12/4/2021)

The laundry rooms were noted as repaired as of the December 6, 2021 inspection. Below are photographs depicting the condition of the ceilings, fire alarms, door hardware, and overall condition of the laundry areas.

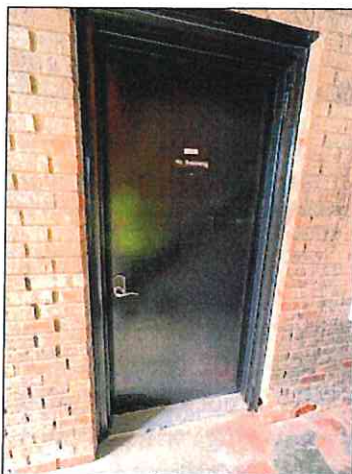
Pine Lake has also added door locks to each laundry room in an effort to ensure doors remain closed when not in use.

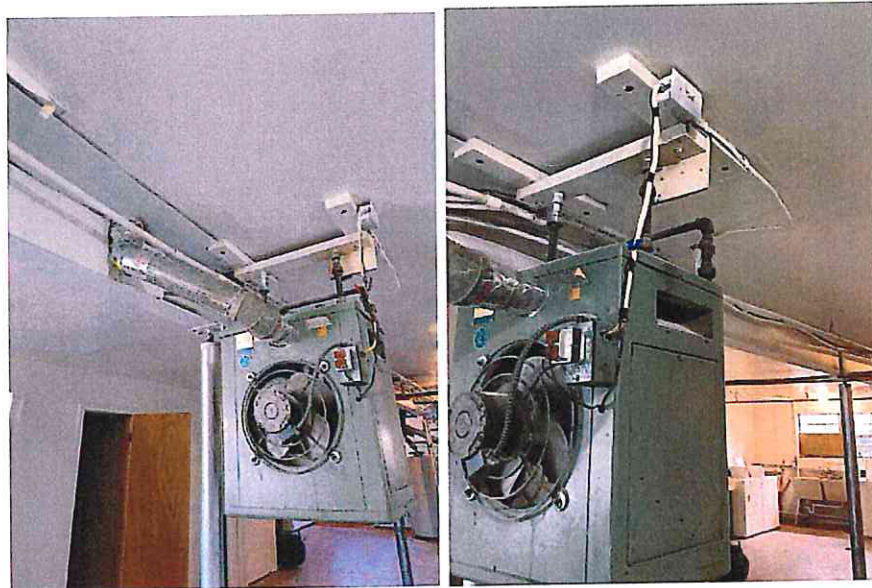
Utilities
Is venting obstructed on fuel heating equipment? All vents shall be clear of obstructions on fuel heating equipment. 2012 NFPA 1 11.5.4 <b>Status: FAIL</b> <b>Notes:</b> Heaters in the laundry room are missing or have displaced vent pipes. 12/6/2021 These conditions still remain.

As of December 6, 2021, all of the laundry room heaters were properly operating and venting with the exception of two. Now, as of the date of this letter, Jolly Plumbing serviced the remaining units, installed a new thermostat with a locking cover and covered exposed thermostat wires. Vents for these units are also now repaired.

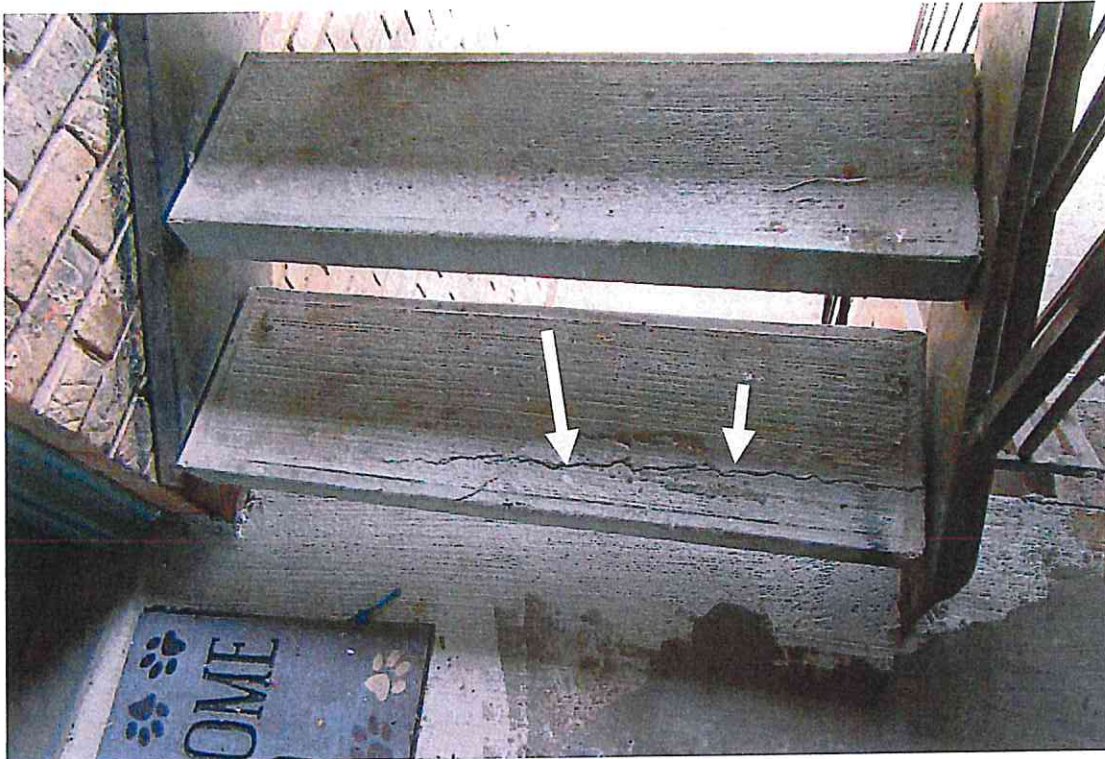
**PHOTO #3 (Unit #101)**

From a structural perspective, there are multiple treads which are structurally deficient and should be replaced, see photos #2 - #4. The exact locations along with their severity are marked in Appendix B. In addition to the structural issues, the majority of the treads are unevenly spaced in elevation. The building code requires that the difference between treads is not to be greater than 7 ¼” and that there is not more than a 3/8” variation between successive step surfaces. We found that these geometric provisions are not met by almost any of the stair stringers in this complex.

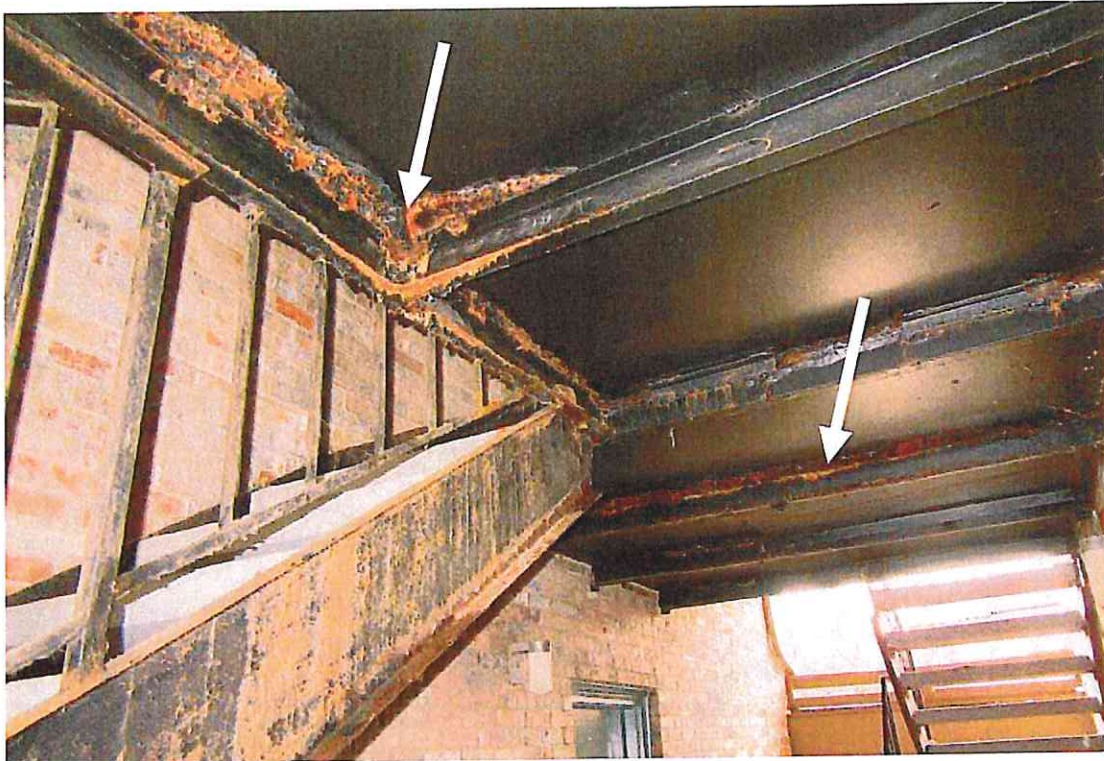
**PHOTO #7 (Unit #125)**

In the 2016 report we found that multiple landings were structurally deficient at that time and we recommended their replacement. We designed replacement landings and stair stringers. During our most recent visit we found that many of these had been replaced, but the structural sizes which we specified in our drawings were not used. Smaller sizes were used. These smaller sizes are structurally deficient as they do not have adequate strength to resist the forces mandated by the building code. Additionally, there are some landings with deteriorated members which we rank as “dangerous” at units #121, #125, #7153, and #7959. These range from metal plates which are peeling off the bottom and are about to fall to connections at the walls which are in the process of collapse. See photos #5 - #8 for some examples of deficient areas.

Additionally, the replaced landings were not replaced using the structural sizes specified on our drawings. These landings do not meet the provisions of the building code. We recommend that they be replaced according to the drawings which we have already provided.

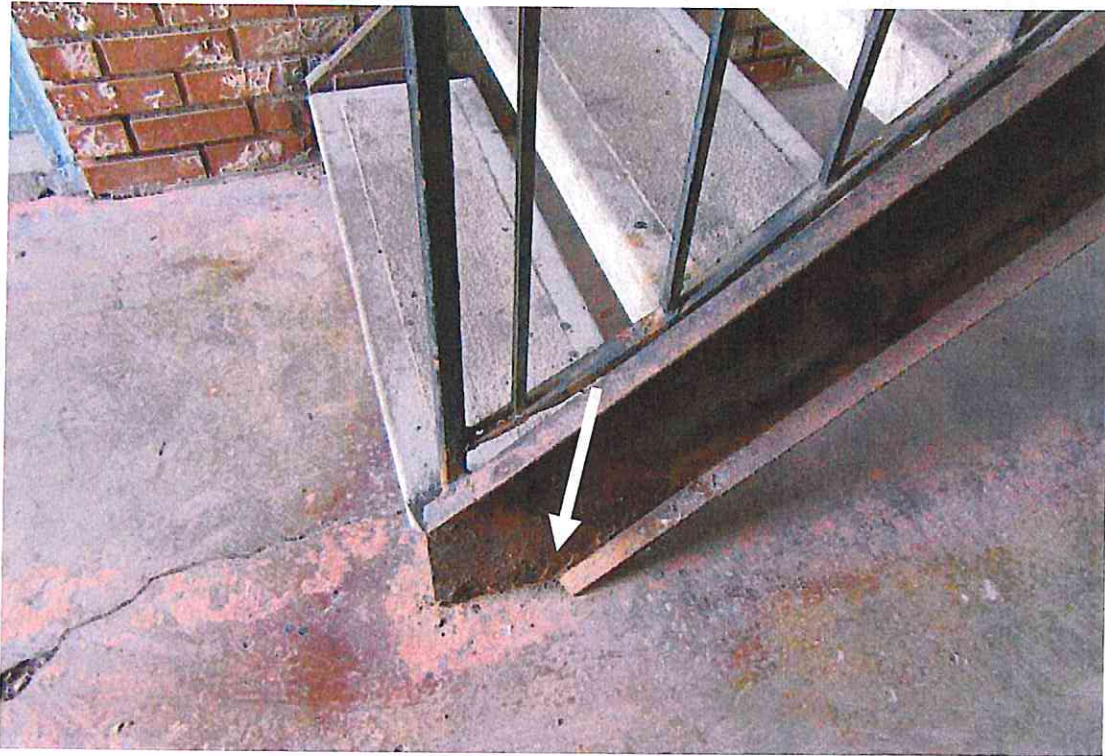
**PHOTO #9 (Unit #7959)**

At multiple locations the steel stringers are heavily rusted. Units #125 and #7959 have stringers which we classified as “dangerous”, see photos #9 - #11.

In general the stair cases are in poor to dangerous condition. All of the locations where the steel landing pans have rusted through or the concrete treads have cracked have been classified as dangerous conditions. At locations where the stairs or landings are classified as being in dangerous condition they should be immediately shored up or closed down. Dangerous conditions exist at the following locations:
