# VIOX & VIOX

## BOONE VALLEY WATERSHED STUDY

# **Boone Valley Watershed Analysis Executive Summary**

City of Florence  
Kentucky

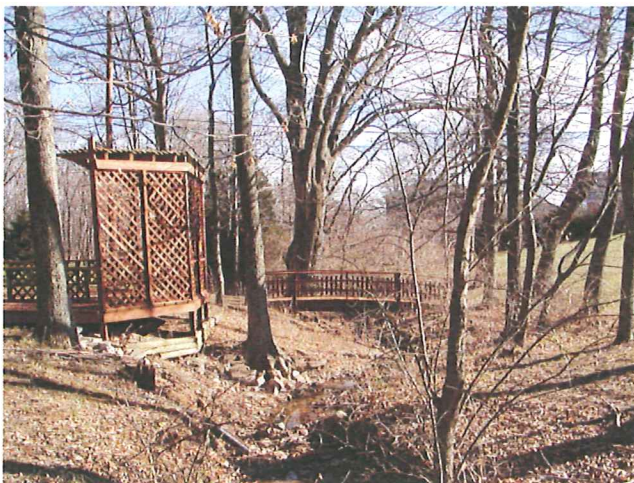
*Bridge and Gazebo @ 8763 Boone Place*

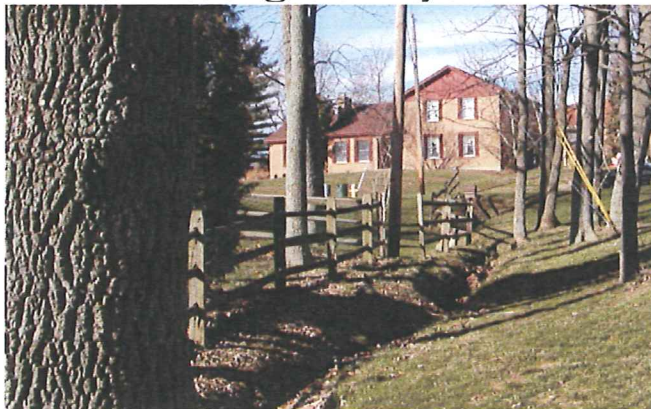
*Bank Erosion @ 6878 Valley Circle*

Many of the residents' comments were concerned with erosion of the channel and surrounding areas. While erosion is a difficult phenomenon to quantify, development in the drainage basin has certainly increased flow rates and velocities in the channel and thus contributed to additional

erosion. Another contributing factor in erosion is the quality and amount of vegetation on stream banks. Through the questionnaires and visual inspections, it is apparent that many residents have mowed or cleared their yards up to and including the stream banks. This lack of vegetation will result in significant erosion even under natural (undeveloped) flows. It should also be noted that the one resident in Zone 1 who did not feel the situation was critical has left significant vegetation along their creek bank, which has helped to protect it.

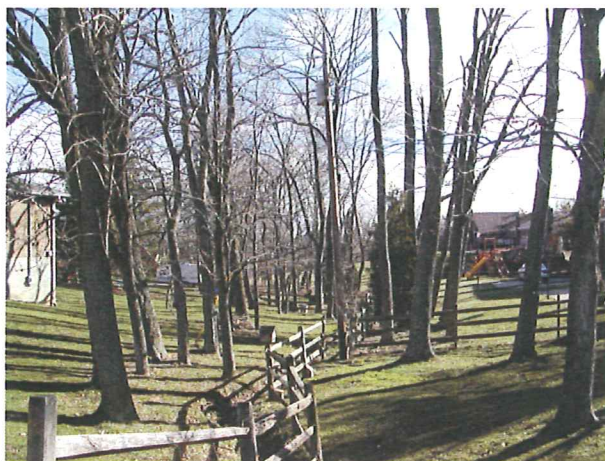
*Looking Downstream @ 6878 Valley Circle*

- Extend the existing storm sewer at 6878 Valley Circle Drive.

This recommendation is dependent upon easement dedication from residents as well as Federal stream permitting. After much consideration, it was determined that the most effective solution to the erosion issues in the northwest portion of the watershed was to extend the storm sewer piping. "Green" solutions were considered but the low environmental quality and potential of the stream make a piping solution possible. A

flow restrictions. Therefore we recommend that the storm sewer be extended. This project would depend on resident cooperation and easement acquisition. Also, the route of this pipe will have to be carefully selected, as several residents expressed reservations about losing existing vegetation along the creek.

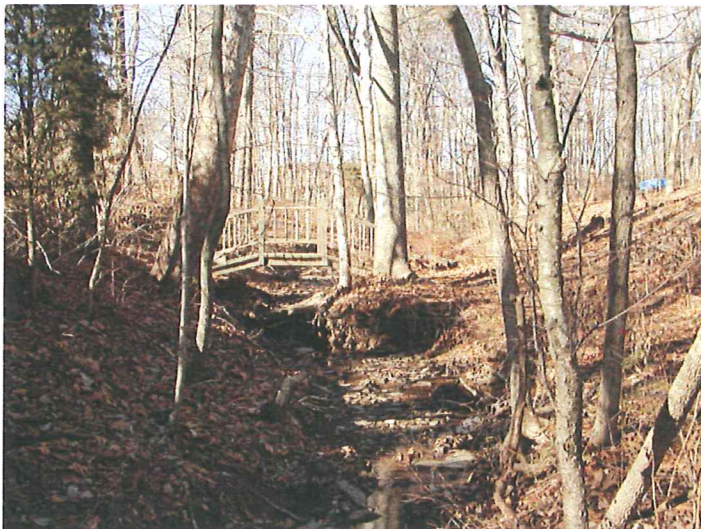
#### *North of Boone Valley Drive*

The area of creek just north of Boone Valley Drive has been left largely untouched and the stream bank vegetation has been maintained. As a result, the creek is in good environmental condition. The section of creek south of Boone Valley Drive is characterized by a widening flood plain with softer slopes. Based on this condition, most bank side vegetation has been removed and several

residents have enclosed the creek in private culverts to expand their yards. These private culverts are the cause of the standing water noted in the residents' comments. With resident cooperation, we recommend that these culverts be removed and the stream banks be restored and stabilized.

- Remove existing private culverts and restore creek vegetation south of Boone Valley Drive.

The portion of the creek just north of Boone Valley Drive is generally in good condition. The local residents have left the creek essentially in a natural state. However, the portion of the creek south of Boone Valley Drive is characterized by a widening flood plain and softer slopes around the creek banks. Because of this fact, several residents have enclosed the creek in private culverts, causing ponding. Additionally, this section of creek has been essentially cleared of bank vegetation. We recommend that the City consult with residents as to the removal of these private culverts and the re-vegetation of the creek banks. Obviously, this would require resident cooperation since the areas in question are located on private property. However, undertaking this effort would provide a long-term environmental benefit to the stream and the community.

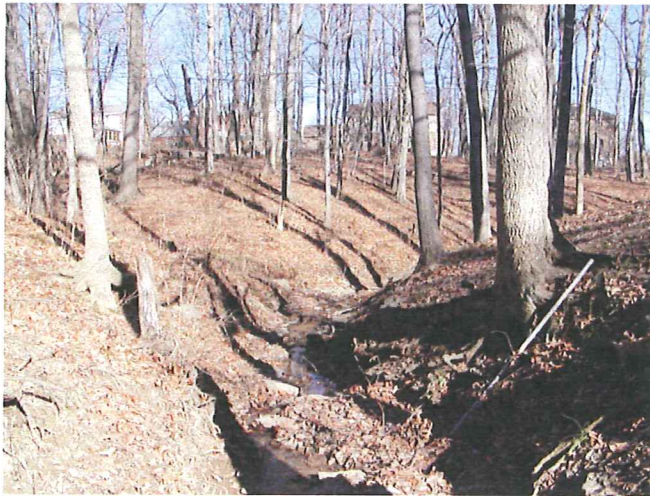
*Bend in Creek*

This recommendation requires no immediate action. There is a significant bend in the creek channel behind 8756 & 8757 Heritage Drive. Due to this change of direction, the bank behind these homes has eroded. This problem would be largely a private issue except for the fact that the erosion could eventually threaten public sanitary sewers. As of now, the existing creek bank vegetation is effectively

stabilizing this area. The residents should be encouraged not to remove this bank vegetation. The City and the residents should continue to monitor this situation to avoid any future issues.

- Monitor the bank erosion between 8756 & 8757 Heritage Drive.

While do not believe any action is necessary at this time, we recommend that the City continue to monitor the creek erosion between 8756 & 8757 Heritage drive. Vegetation is currently stabilizing the creek bank. However, if the vegetation is removed or dies the bank could begin to erode into the resident's yards.

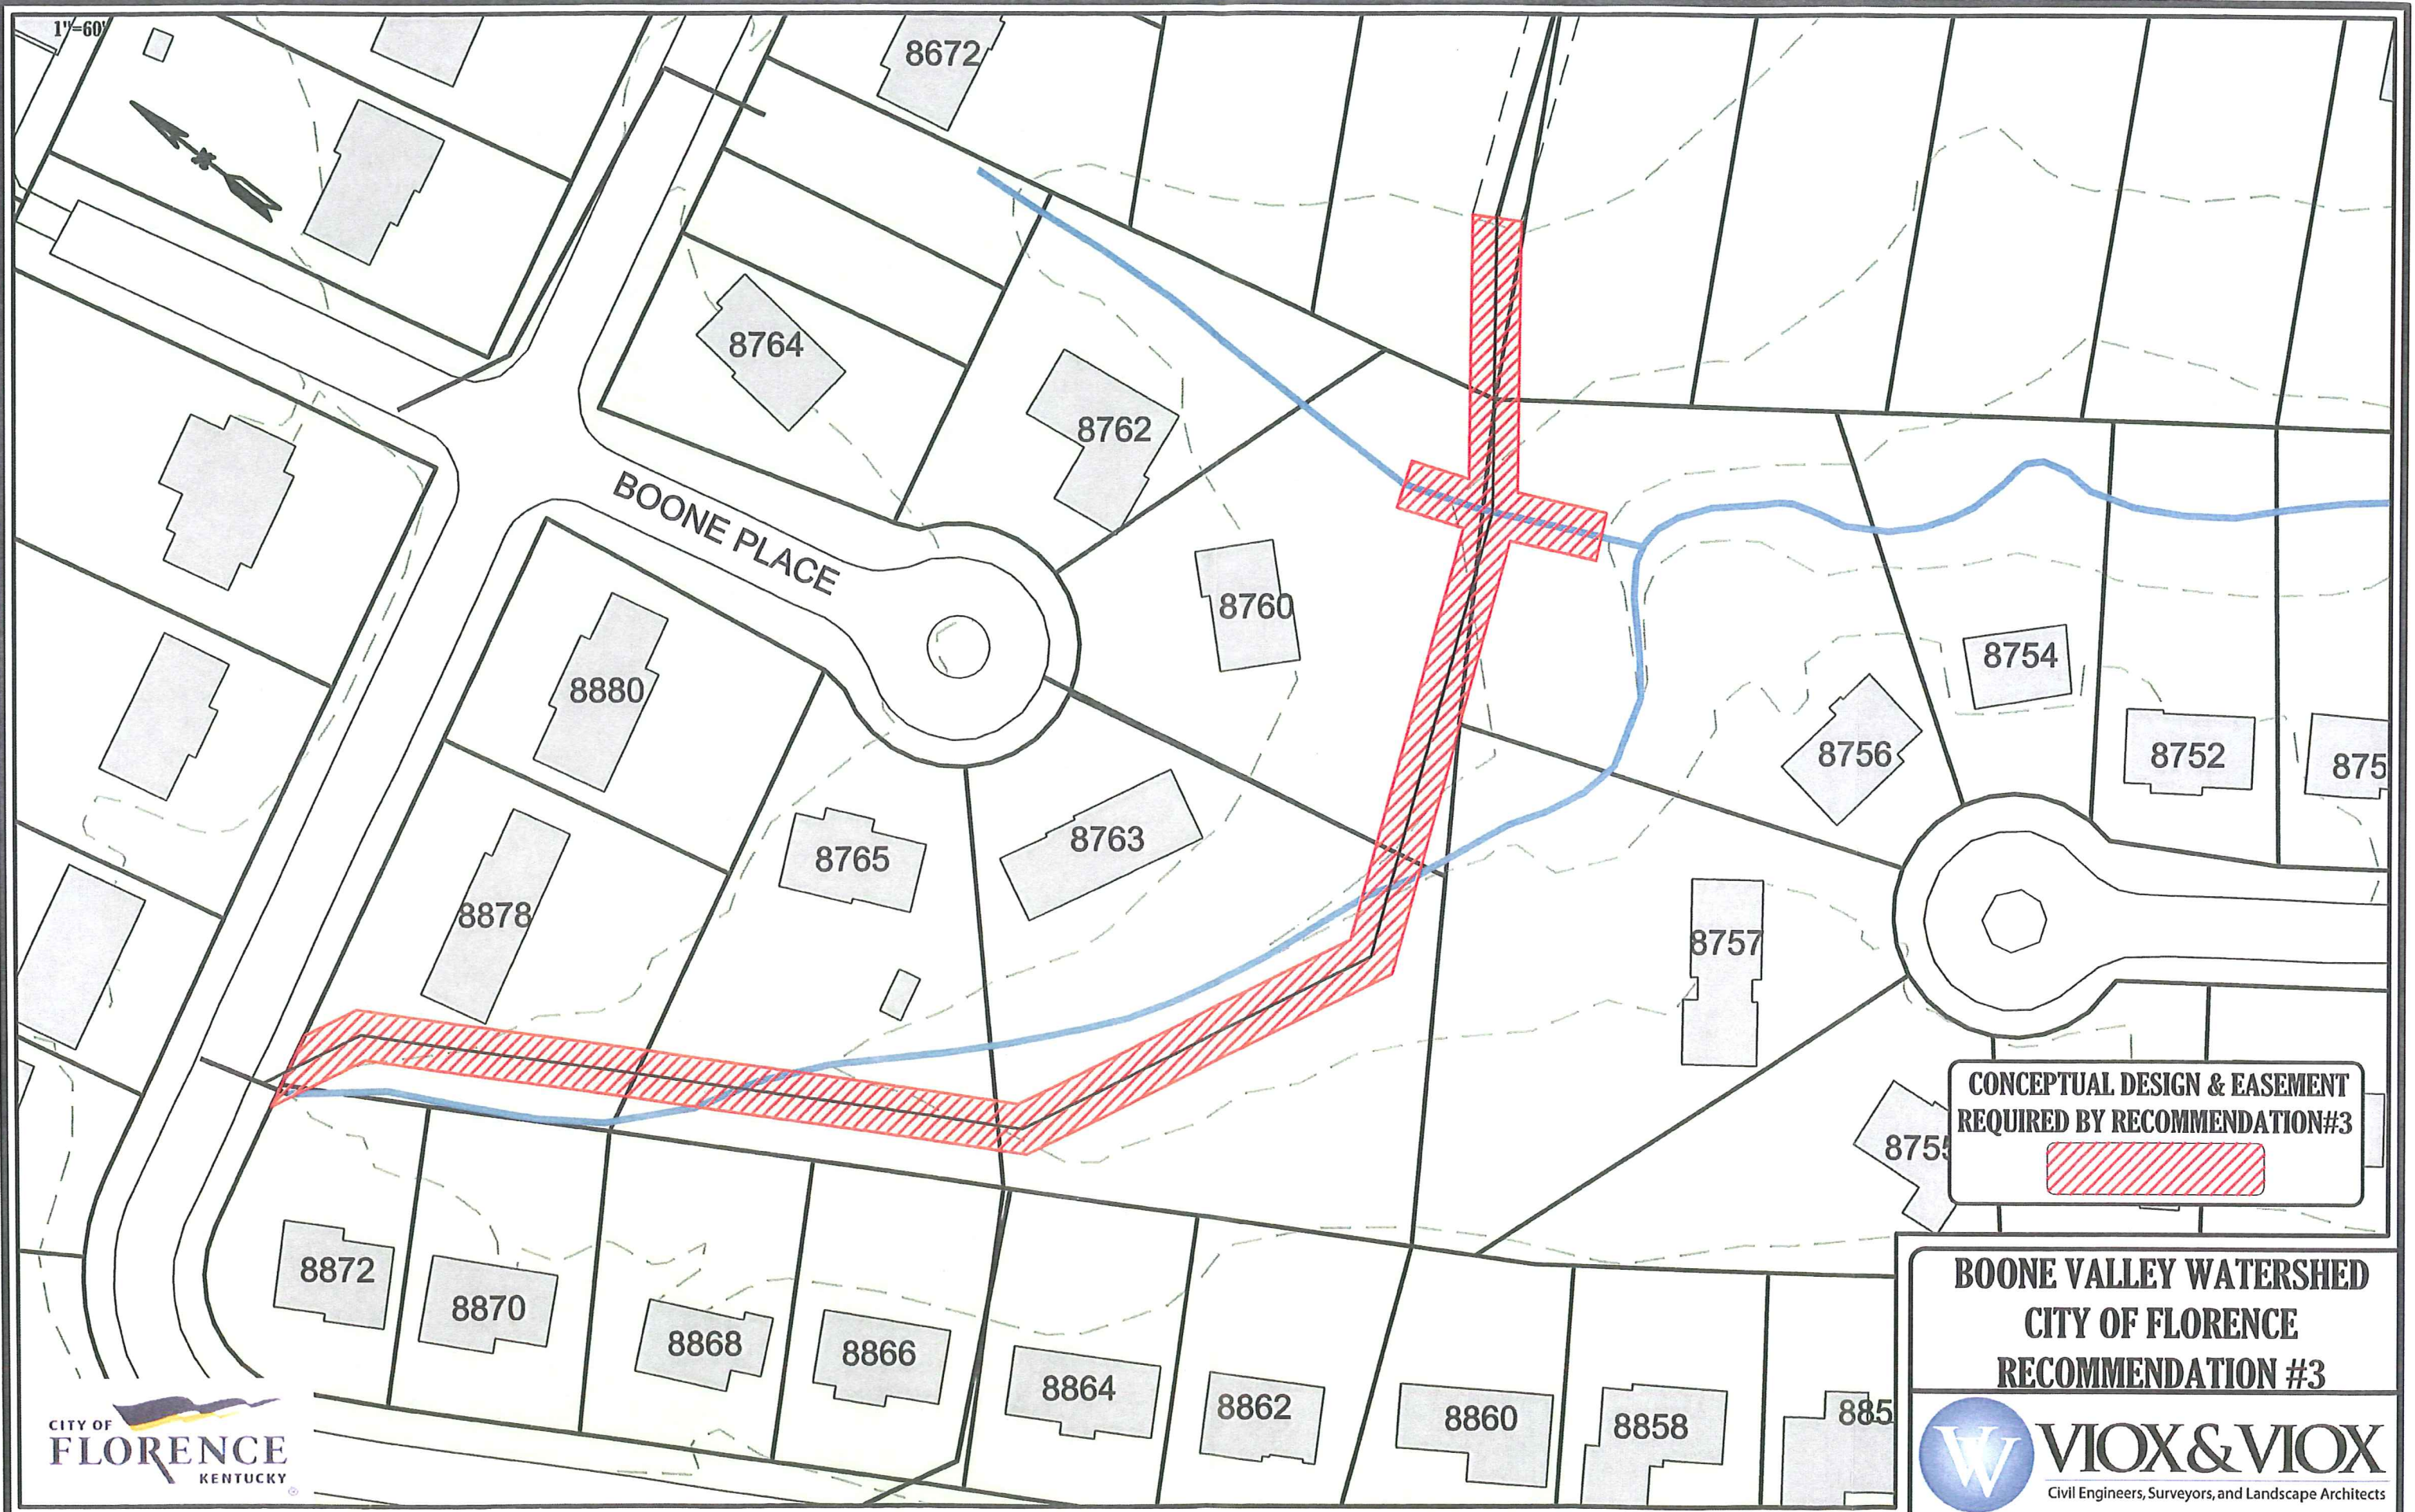
CONCEPTUAL DESIGN & EASEMENT  
REQUIRED BY RECOMMENDATION #3

**Recommendation #3 - The Boone Valley Watershed Study revealed an existing erosion issue in the northwest section of the watershed. The study recommends that a storm sewer be constructed to re-route the small drainage channel through the rear yards.**

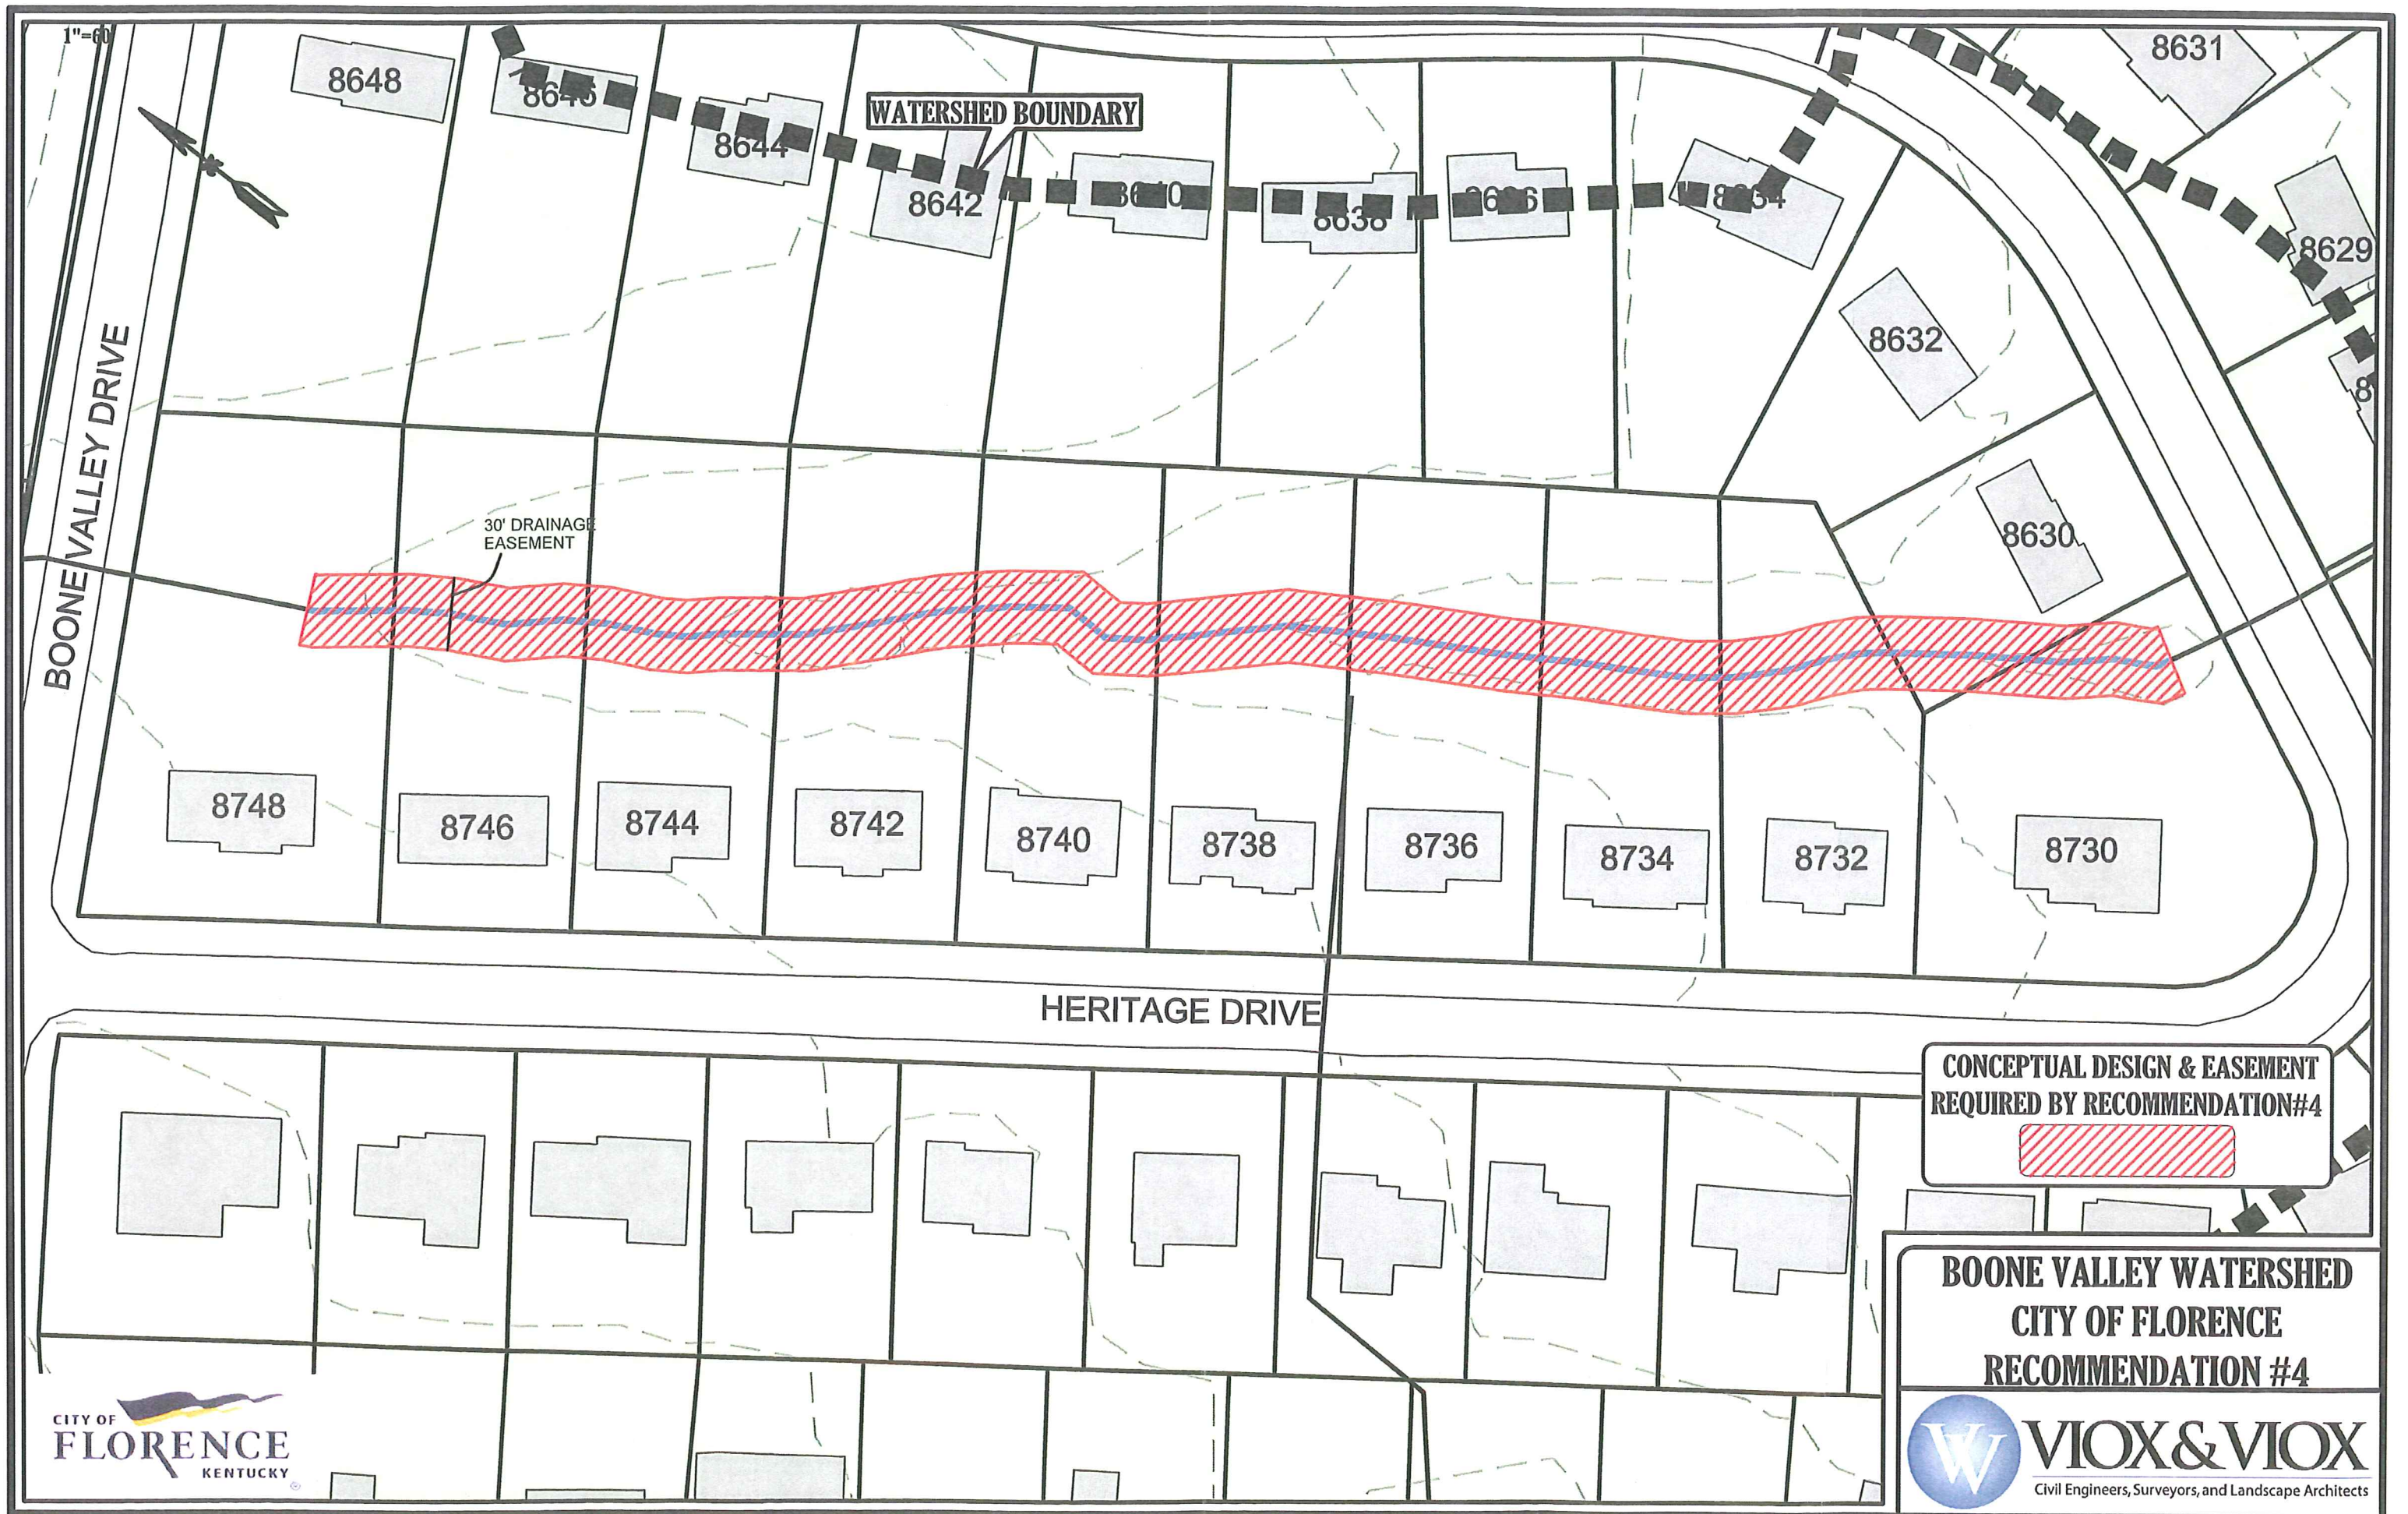
CONCEPTUAL DESIGN & EASEMENT  
REQUIRED BY RECOMMENDATION#4

**Recommendation #4 - The Boone Valley Watershed Study exposed the existence of several private culverts in the southern portion of the watershed. It was recommended that these culverts be removed and the creek channel be remediated and restored. This cannot occur without resident cooperation.**
