PINELAKE APARTMENTS

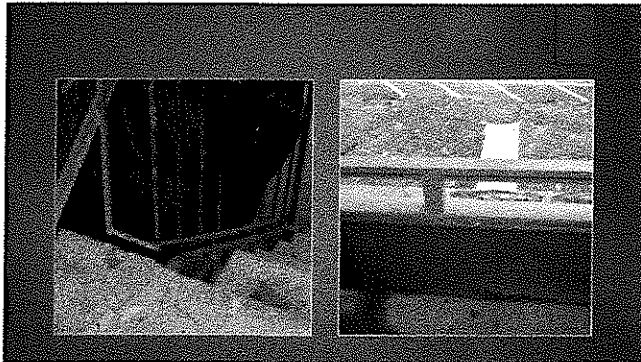
- Railings on the stairs are painted green all the way up. Much of the railing is showing signs of rust and deterioration. There are no railings on the stairs with missing or broken anchoring hardware. The entire railing along the parking lot of the Pinehurst is a state of disrepair and has been over the wall for many years. The railing appears to have been broken and approximately 40 feet of the railing has been removed.
- The wooden railings at the top of the stairs look like they have been painted and are in good condition.

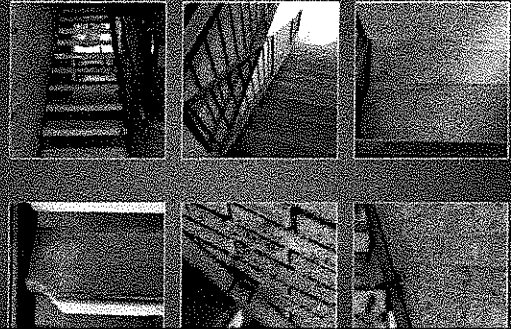
- Railings are lacking in many areas. Much of the railing is showing signs of rust and deterioration. There are areas of the railing with missing or broken anchoring hardware. The exterior railing along the parking lot of 102 Pleasant is in a state of disrepair and has fallen over the wall behind it. The fence appears to have been struck and approximately 40 feet of the fence has been displaced.
- The wooden railing of the landing of the steps has paint, has areas of mold, rot and missing wood.

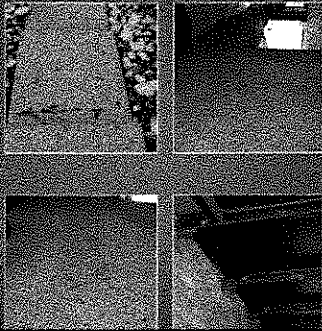
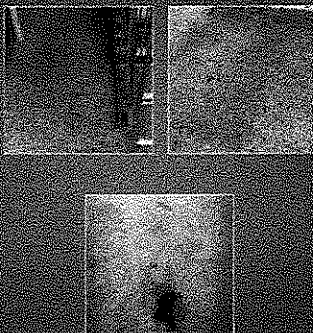
Storage

- A large amount of wood, furniture and debris are being stored on the landings.

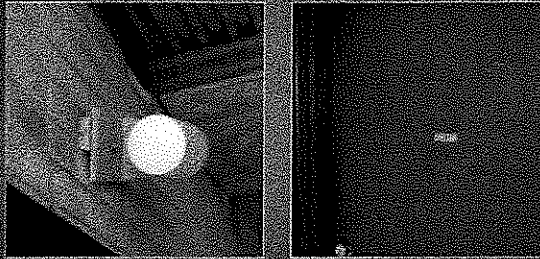
Electric

- Lighting fixtures are falling off the wall and sparking wires by Apartment #4.

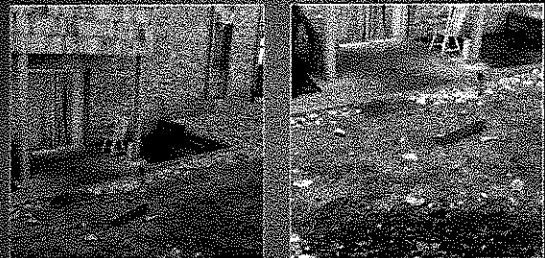
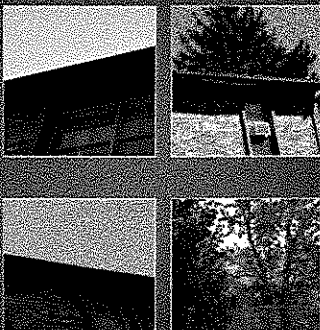
Roofs-Gutters

- The rafters of the roof line show areas that are missing or loose and not nailed. The sides of the roof above the breezeway steps appear to be missing and are currently covered with plastic.

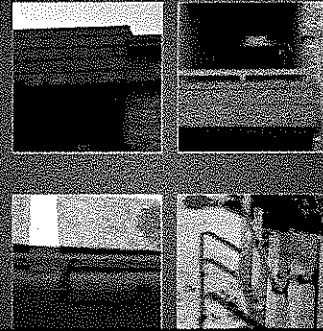
Siding and Trim:

- Siding and trim on the building show significant signs of deterioration. The siding consists of wood shingle, painted blue. These shingles cover the bulk of the roof directly above the breezeway and patio walk directly below windows. The siding is in need of paint and show significant signs of fading or fading no paint at all. There are multiple areas where the siding's missing, has rotted away, leaving holes and gaps.

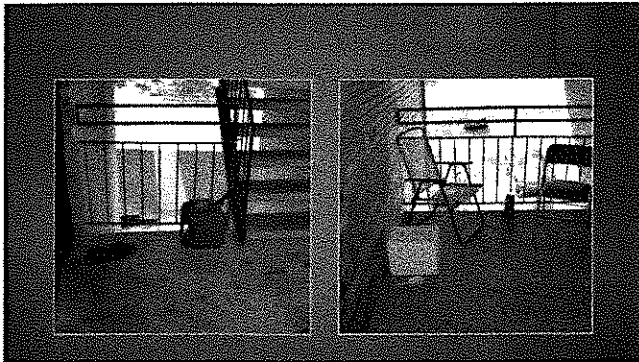
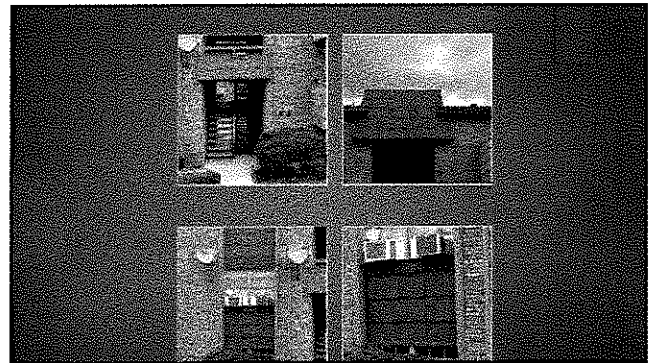
Siding and Trim:

- Siding and trim on the building show significant signs of deterioration. The siding consists of wood shingles painted blue. These shingles cover the sides of the roof directly above the breezeways and also areas directly below windows. The siding is in need of paint and show significant signs of fading or lacking no paint at all. There are multiple areas where the siding is missing, has rotted away leaving holes and gaps.

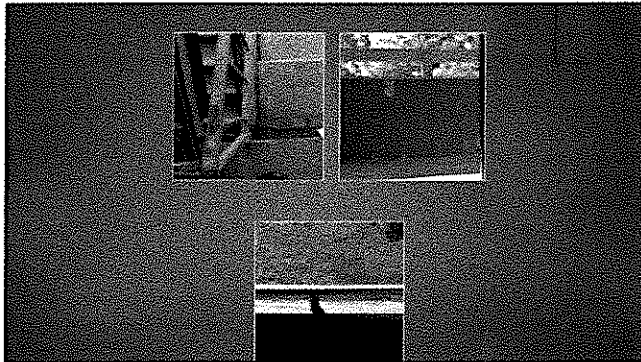
- Railings are lacking in paint across all locations. Much of the railings are showing signs of rot and deterioration. There are areas of the railings with missing, broken or loose anchoring hardware. The wooden railing at the landing of the steps lack paint, has areas of mold and rot.

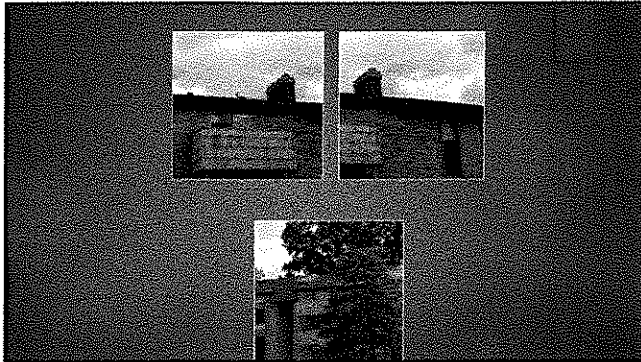
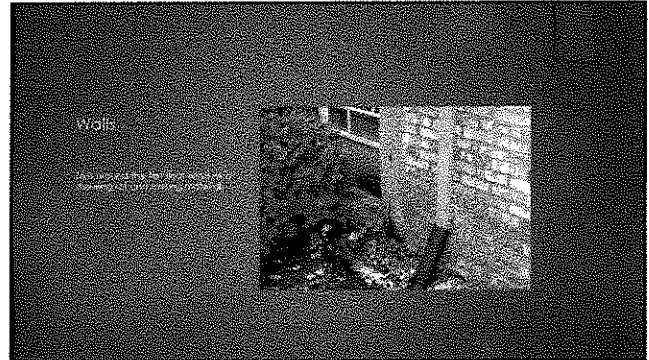
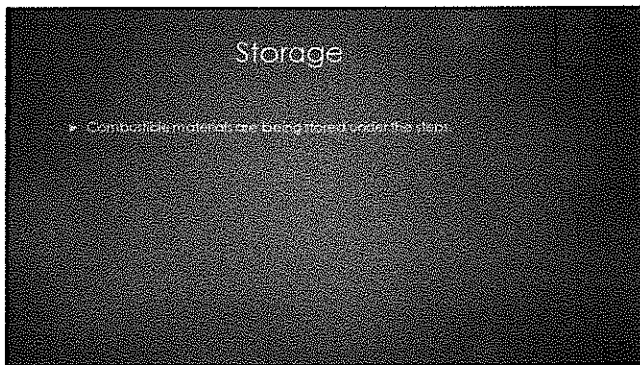
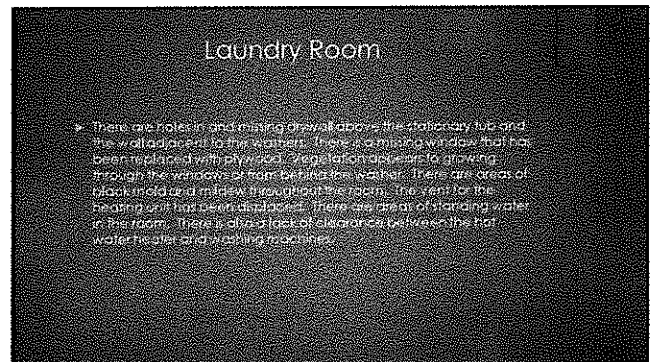
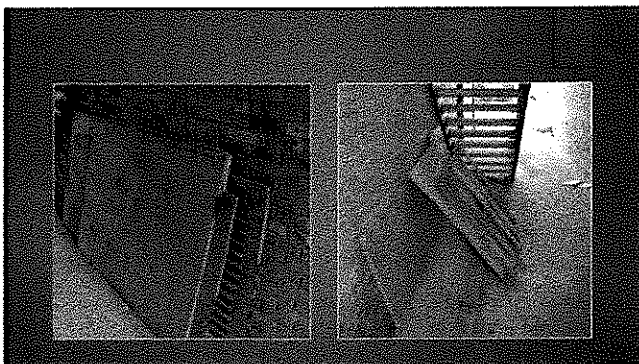
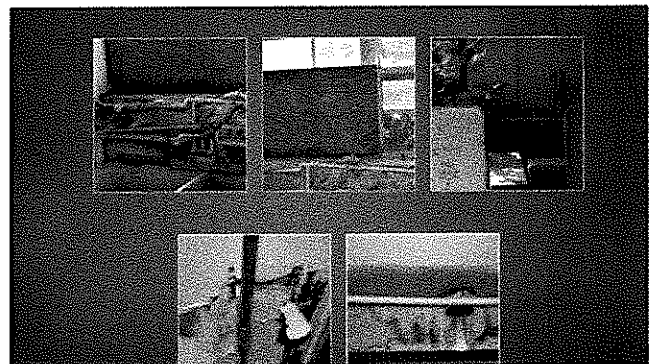
Roofs-Gutters

- The roofline has signs of the split that are missing leaving holes to the attic space. There are areas where the split is loose and showing signs of rot. The roof above the breezeway appears to be covered with plastic.

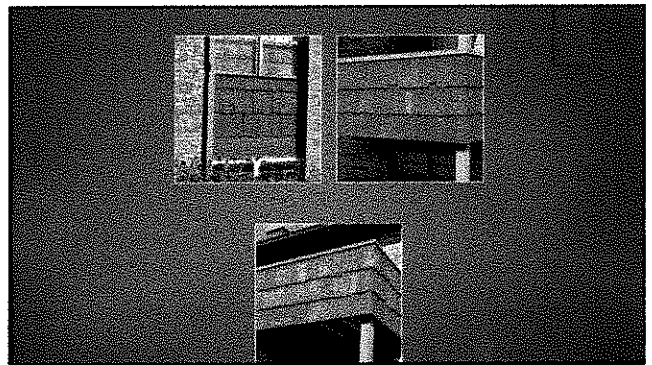
Siding and Trim:

- Siding and trim on the building show significant signs of deterioration. The siding consists of wood shingles painted blue. These shingles cover the sides of the roof directly above the breezeways and also extend directly below windows. The siding are in need of paint and show significant signs of fading or fading no paint at all. There are multiple areas where the siding is missing, has rotted away, leaving holes and gaps.

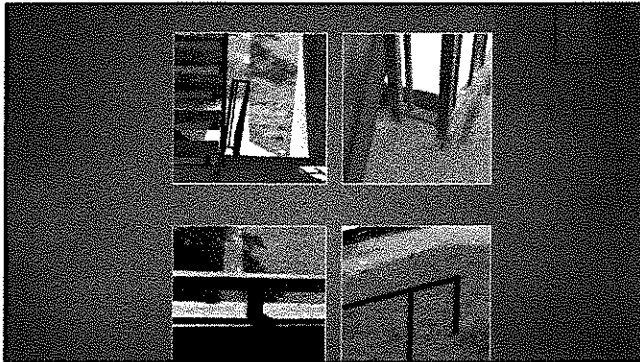
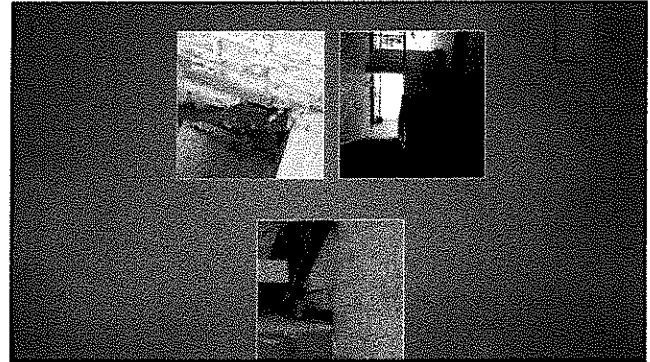
- Railings are lacking in paint across all locations. Much of the railings are showing signs of rot and deterioration. There are areas of the railings with missing, broken or loose anchoring hardware. The railings are leaning and have areas of free floating at the base. The wooden railing at the landing of the steps lack's paint, has areas of mold and rot.

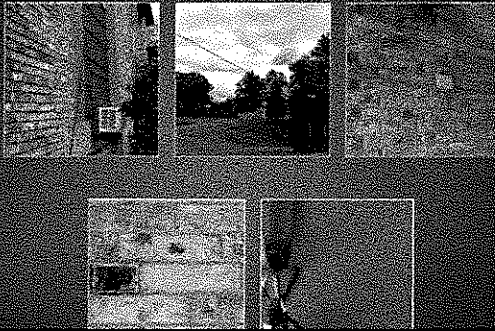
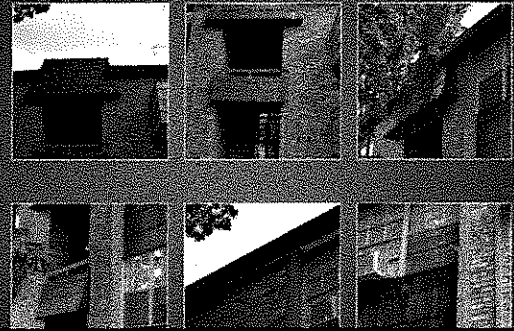
Siding and Trim:

- Siding and trim on the building show significant signs of deterioration. The siding consists of wood shingles painted blue. These shingles cover the sides of the roof directly above the breezeway and also areas directly below windows. The siding is in need of paint and show significant signs of fading or lacking no paint at all. There are multiple areas where the siding is missing, has rotted away leaving holes and gaps.

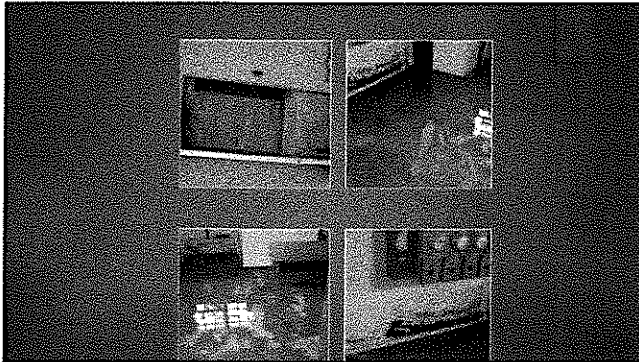
Laundry Room

- The duct closer to the laundry room is rotten. There is standing water on the floor. There are areas of plastic and mildew throughout the room. There are holes and leaks from the ceiling. The venting of the heating system is displaced.

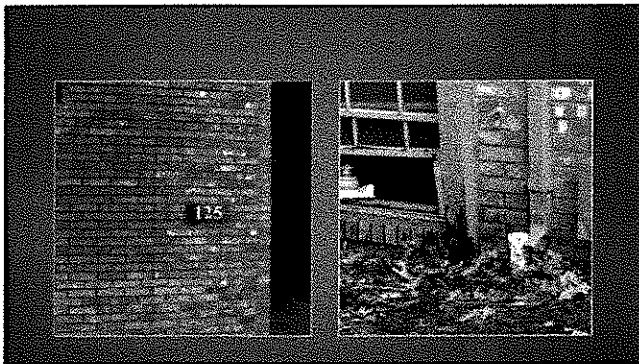
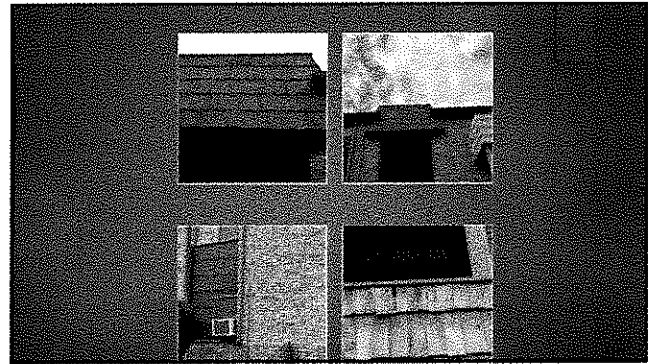
Siding and Trim:

- Siding and trim on the building show significant signs of deterioration. The siding consists of wood shingles painted blue. These shingles cover the sides of the roof directly above the breezeways and also extend directly below windows. The siding is in need of paint and show significant signs of fading or lacking no paint at all. There are multiple areas where the siding's missing has rotted away leaving holes and gaps.

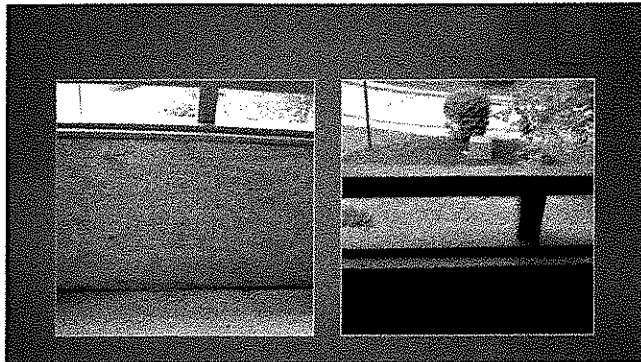
- Railings are lacking in paint across all locations. Much of the railings are showing signs of rot and deterioration. There are areas of the railings with missing, broken, or loose anchoring hardware. The wooden railing of the landing of the steps lacks paint, has areas of mold and rot.

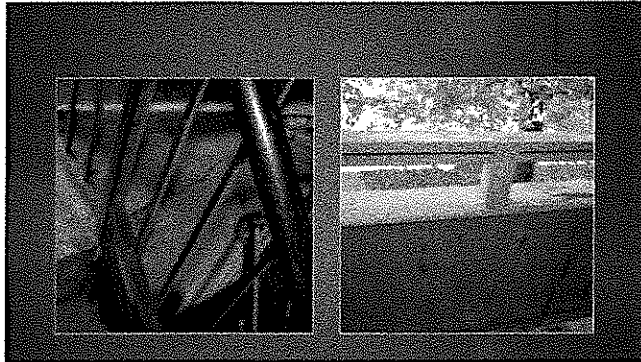
- Railings are lacking in paint across all locations. Much of the railings are showing signs of rot and deterioration. There are areas of the railings with missing, broken or loose attaching hardware. The wooden railing at the landing of the steps lack paint, has areas of mold and rot.

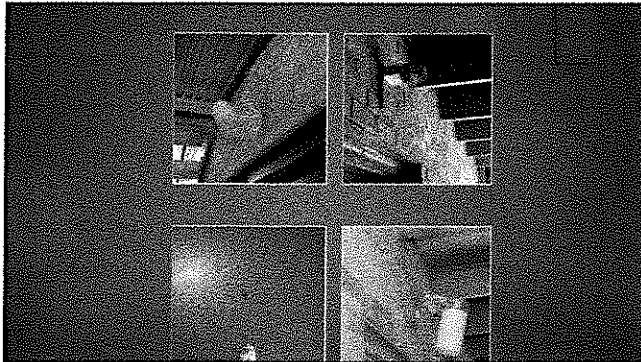
- Conduit of some type has fallen off the building and lying on the ground
- Multiple light fixtures are in disrepair throughout the building. There are areas of exposed wiring from displaced and missing light fixtures.

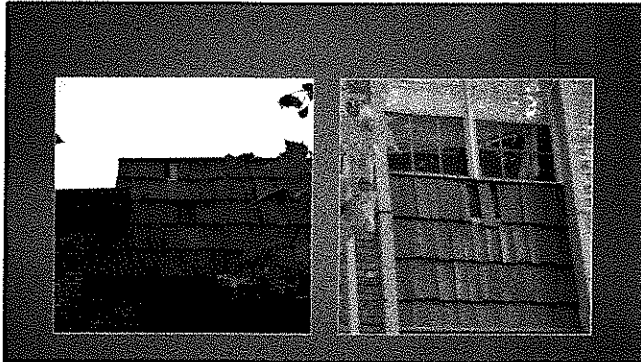
Siding and Trim:

- Siding and trim on the buildings show significant signs of deterioration. The siding consists of wood shingles painted blue. These shingles cover the sides of the roof deck, above the breezeway and also directly below windows. The siding is in need of paint and show significant signs of fading or lacking in paint at all. There are multiple areas where the siding is missing, has rolled away leaving holes and gaps.

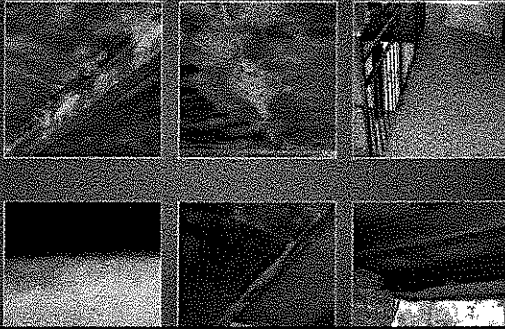
Landings

- The landings are comprised of concrete poured in a pan that is supported on the underside by metal beams. These beams are then supported by metal rods inserted in the brick of the walls. The concrete shows spalling across the entire surface of the landing. There are also significant cracks and shifting of the concrete itself. Both the H-beams and concrete pans show significant areas of rust and holes. There are many areas of building rust indicating further deterioration of the metal of the pans. There is lots of brick and mortar material around the support rods inserted into the brick. There are areas where the deterioration of the brick has had attempts to repair.

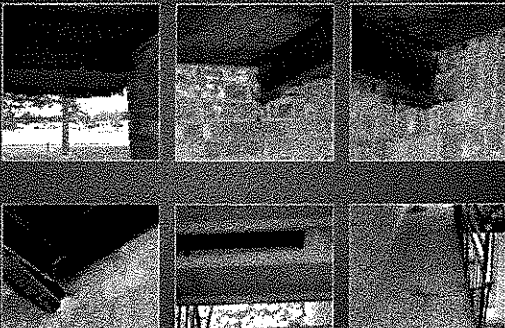
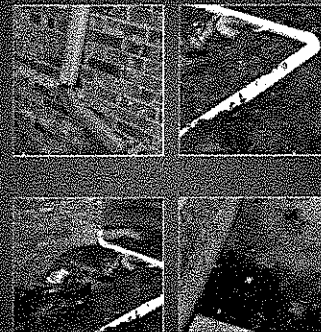
Roof-Gutters

- Gutters are damaged on the building and a gutter on the ground has been buried away.

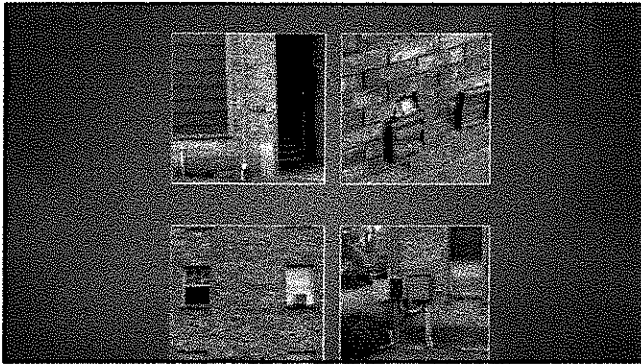
Siding and Trim:

- Siding and trim on the buildings show significant signs of deterioration. The siding consists of wood shingles, painted blue. These shingles cover the sides of the roof directly above the breezeway and also extend directly below windows. The siding is in need of paint and shows significant signs of fading or lacking no paint at all. There are multiple areas where the siding is missing, not rolled away leaving holes and gaps.

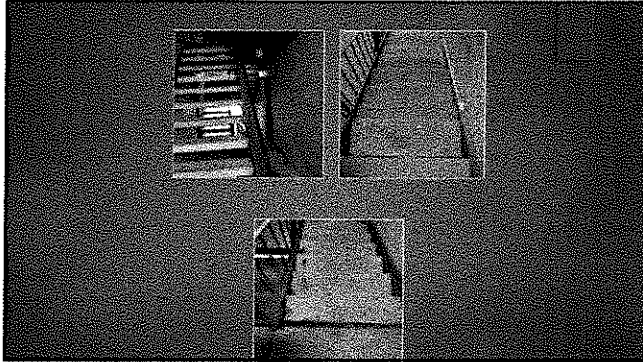
Steps

- The steps and landings of the breezeway have several issues. These breezeways are the only means of egress for both the 4th and 5th floors. The treads of the steps are uneven and are not a consistent depth from top to bottom. The rise of the steps varies significantly from one step to the next and presents a fall hazard. The steps show signs of cracking and deterioration. There are areas of spalling and large chunks of concrete are missing from the steps. Step-tread anchor bolts are missing on one side of each step.

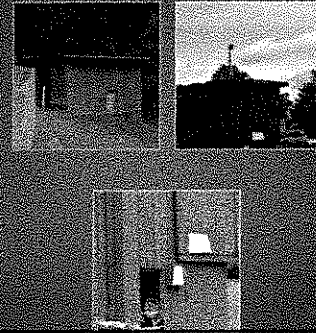
Pool and Out Buildings

- ▶ The pool at Pinelake Apartments is a complete state of disrepair. The water in the pool appears to be from rain water and full of algae. The concrete surrounding the pool is cracked and crumbling. There are weeds and grass overgrowing the pool area and outside the pool fence. The water run off at the rear of the property has garbage throughout the rock bed.
- ▶ The outbuilding presumably the mechanics for the pool and a bathroom are in disrepair and appear structurally unsound. They have multiple areas of rot, holes and are in need of paint. The door appear to be unsecured.

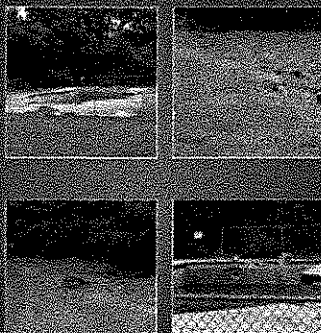
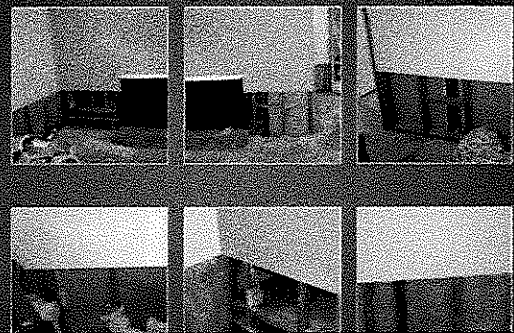
7937 Dixie Highway Apartment 1

- ▶ The apartment is in two bedrooms, one bathroom and a kitchen. The kitchen has a sink, stove, and refrigerator. The bathroom has a toilet, sink, and shower. The bedrooms have beds and dressers. The apartment is in need of maintenance and repairs.
- ▶ The kitchen is in disrepair and needs to be replaced. The sink is broken and the stove is old.
- ▶ The bathroom is in disrepair and needs to be replaced. The toilet is broken and the shower is old.
- ▶ The bedrooms are in disrepair and need to be replaced. The beds are old and the dressers are broken.
- ▶ According to the apartment manager, the apartment has been vacant for several weeks. No further action has been taken to address the issues.

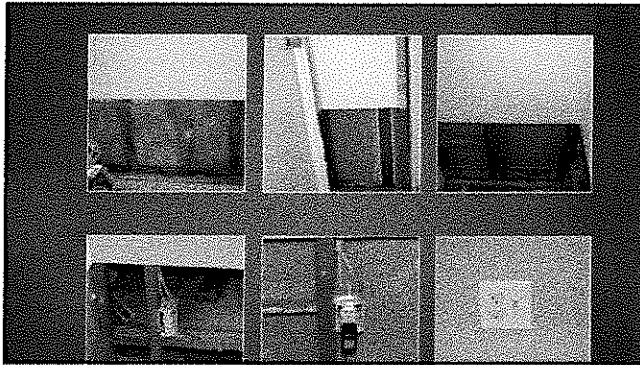
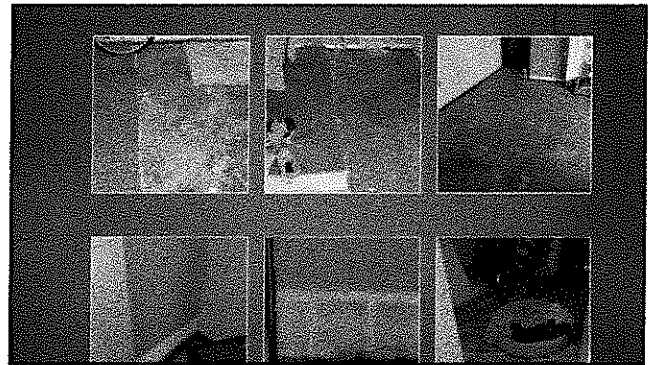
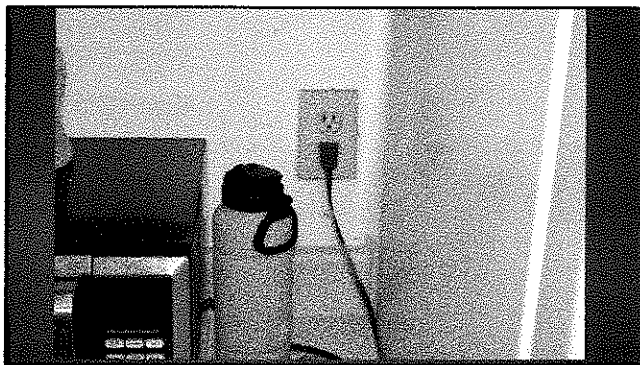
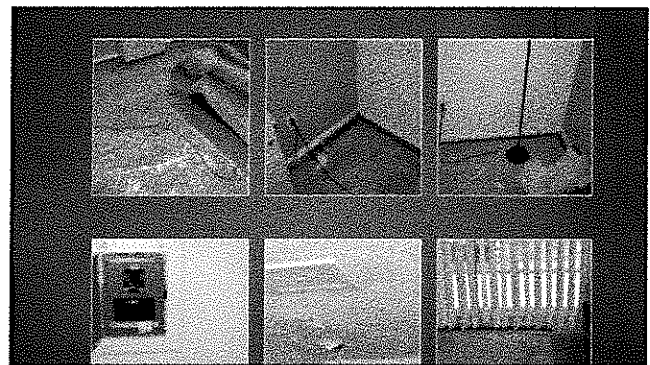
7937 Dixie Highway Apartment #2

* The apartment is a two bedroom first floor unit. It consists of the sleeping area, a common bathroom, galley style kitchen, dining area and a living room. The unit suffered water damage sometime in the past 30 days according to the residents. The water damage came from a toilet in the bathroom back up. Work has been performed to remove the water damaged areas. According to the residents, the work was done at the direction of the property management. The following observations were made:

* According to the resident these conditions have been in place for the past 3 weeks. No further work has been performed and there have been no further flooding issues.

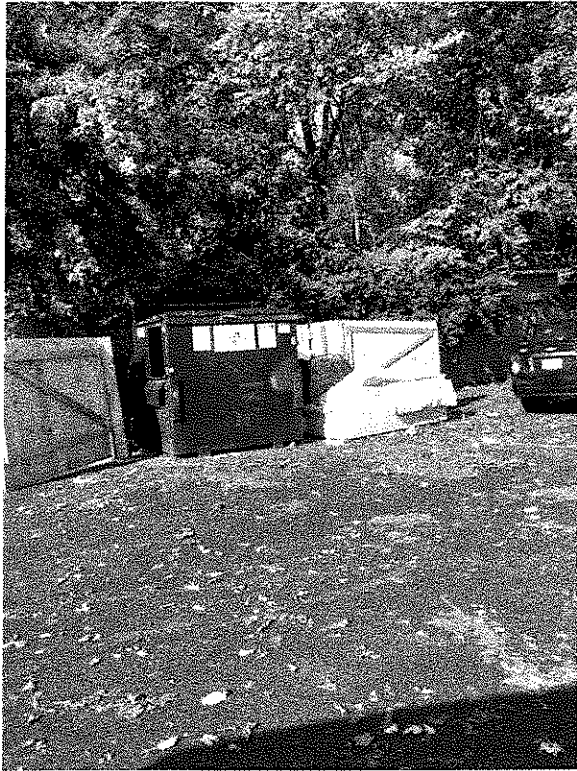
Trash in dumpster area again

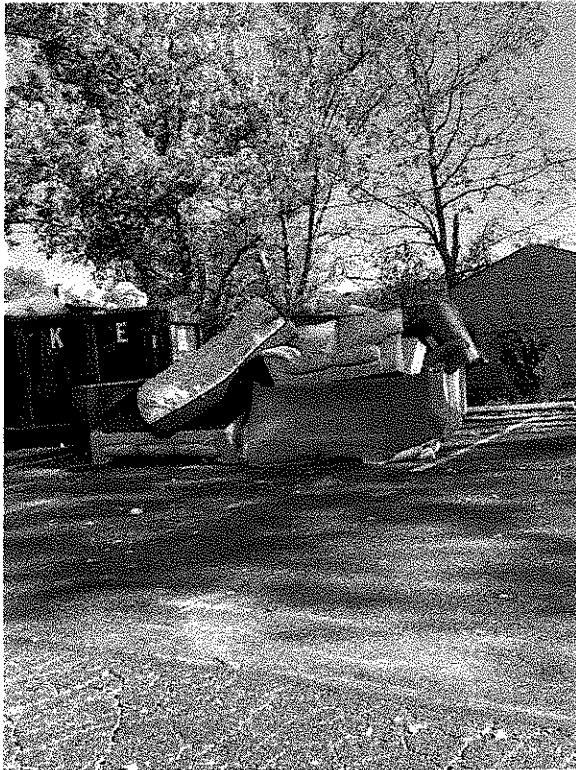
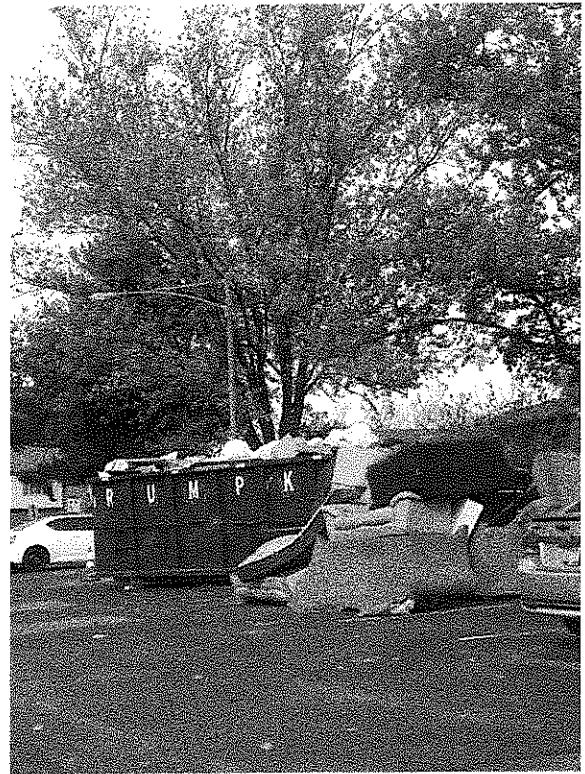
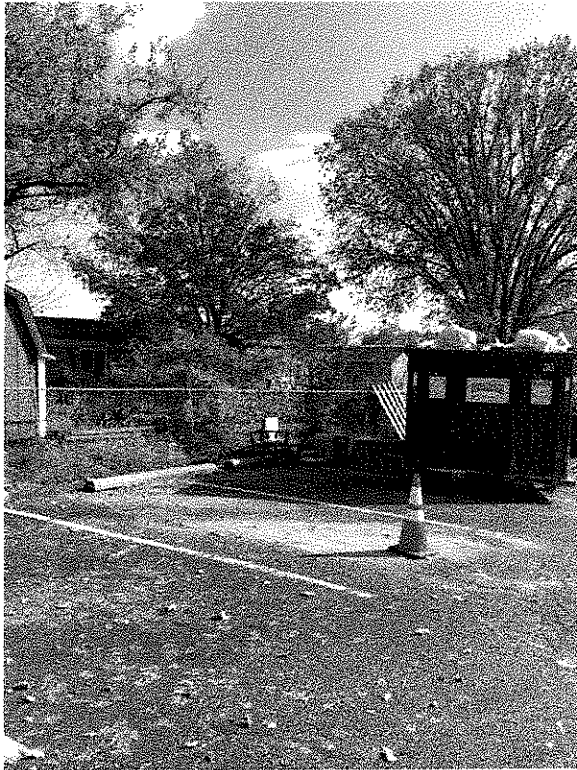
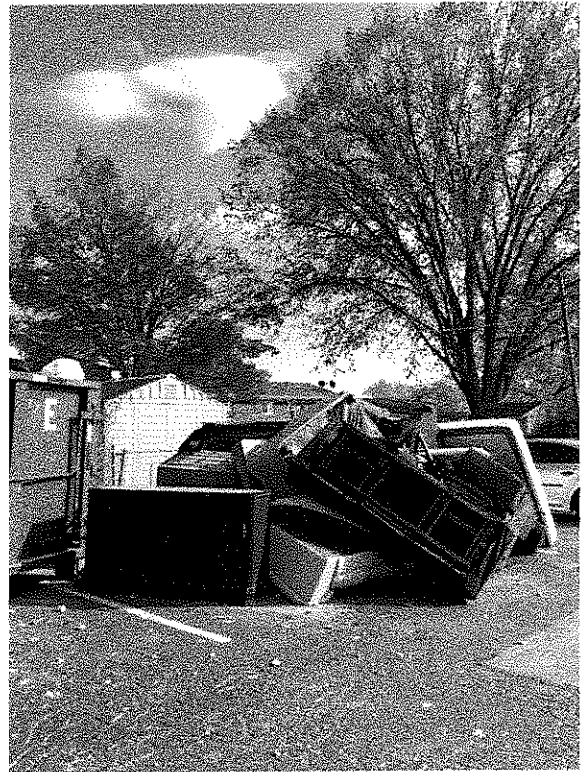
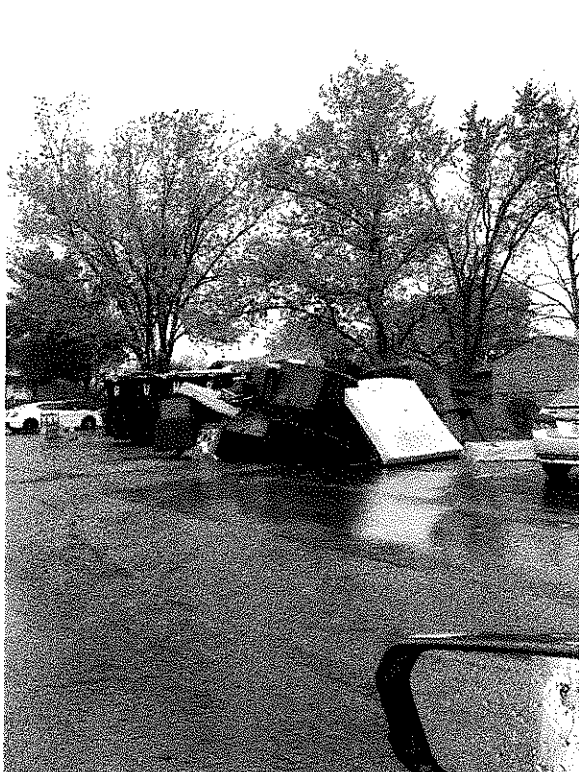
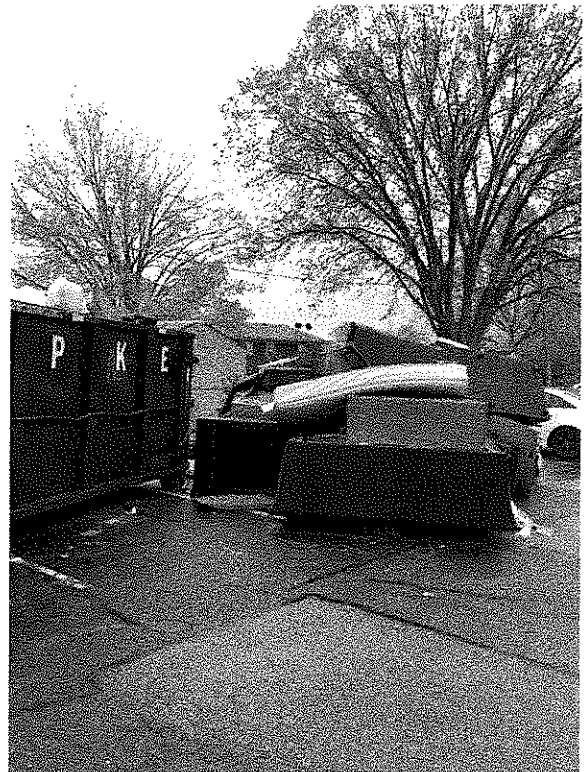
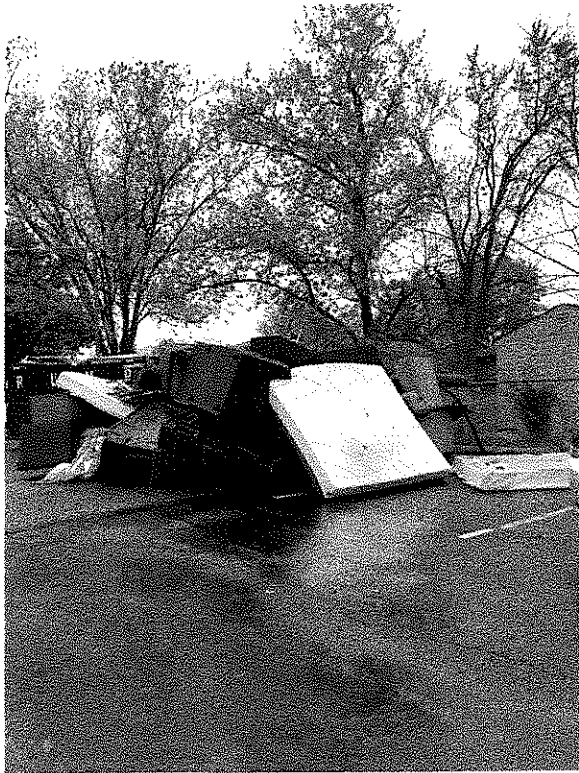
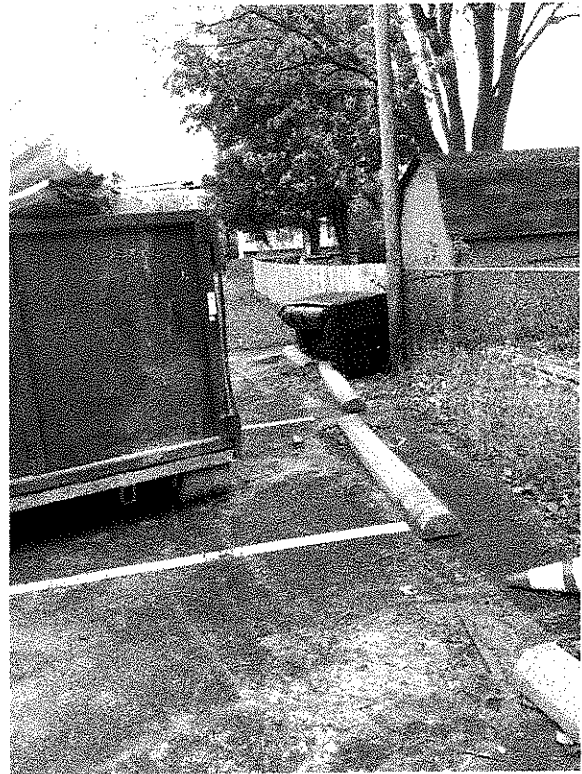
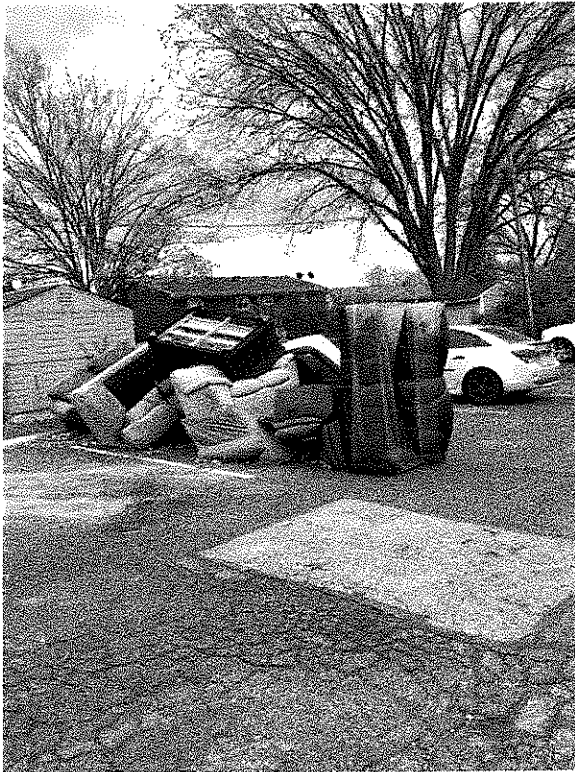
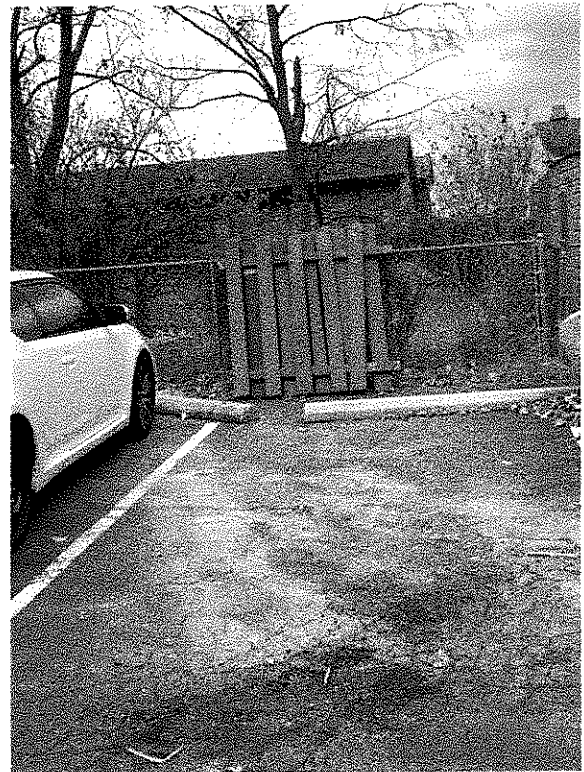
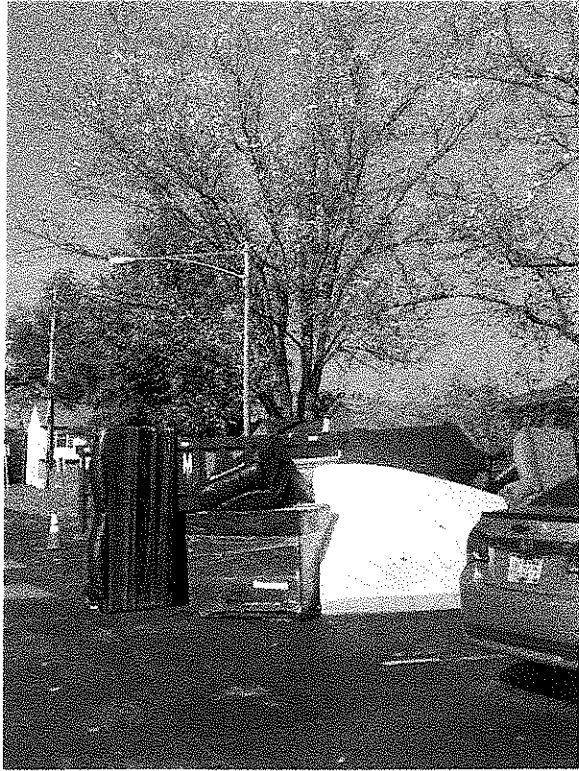
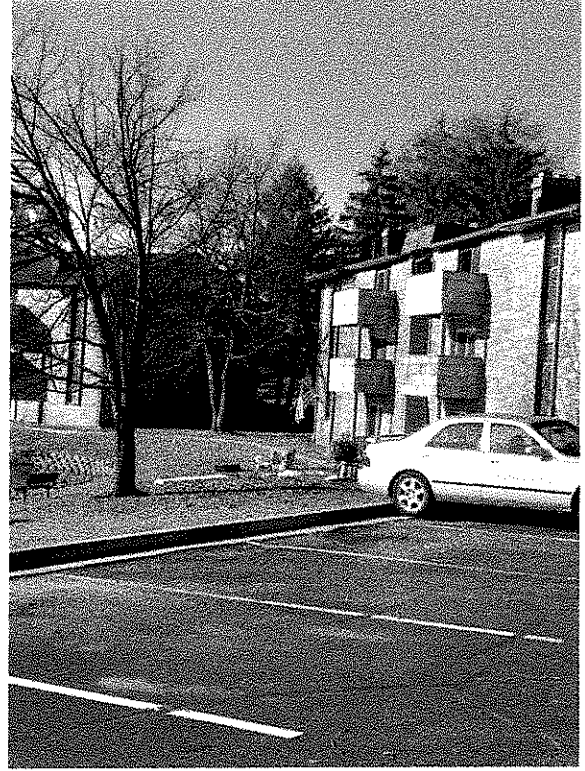
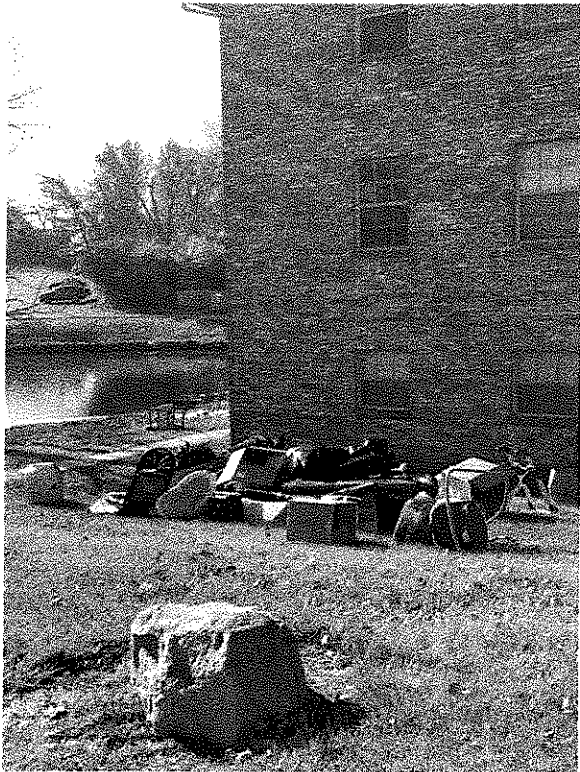
Dumpster have been replaced with empty one

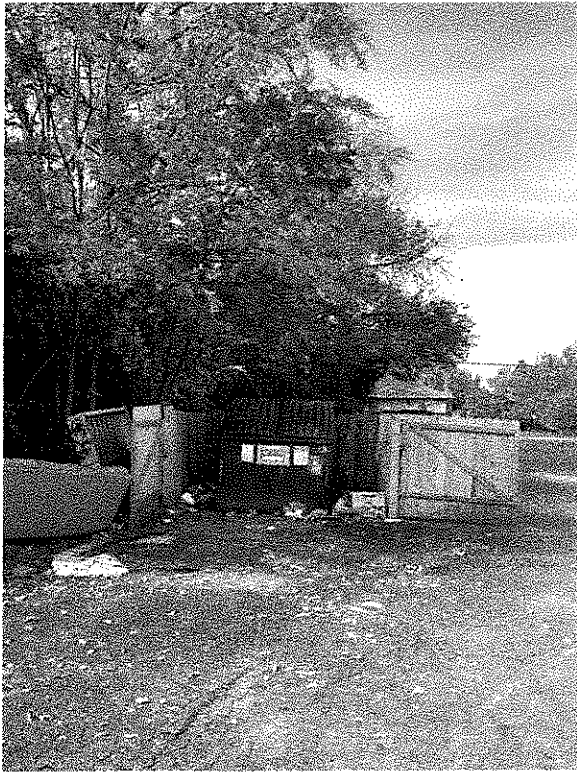
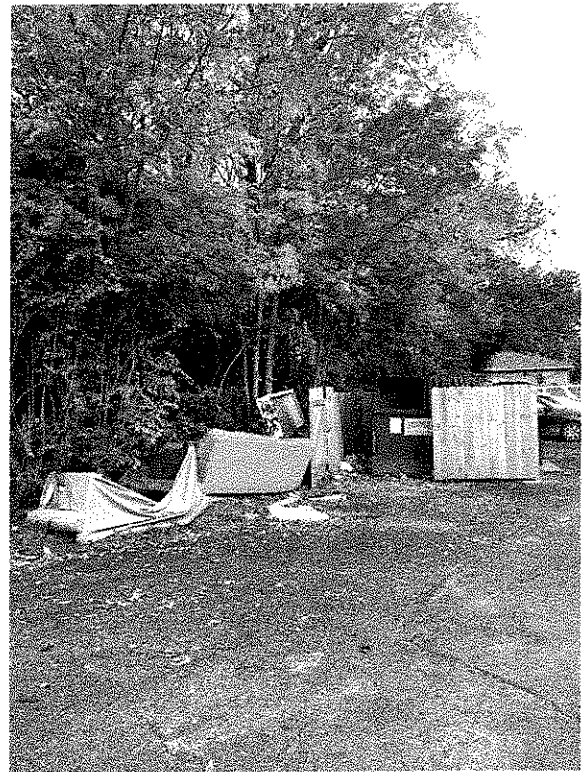
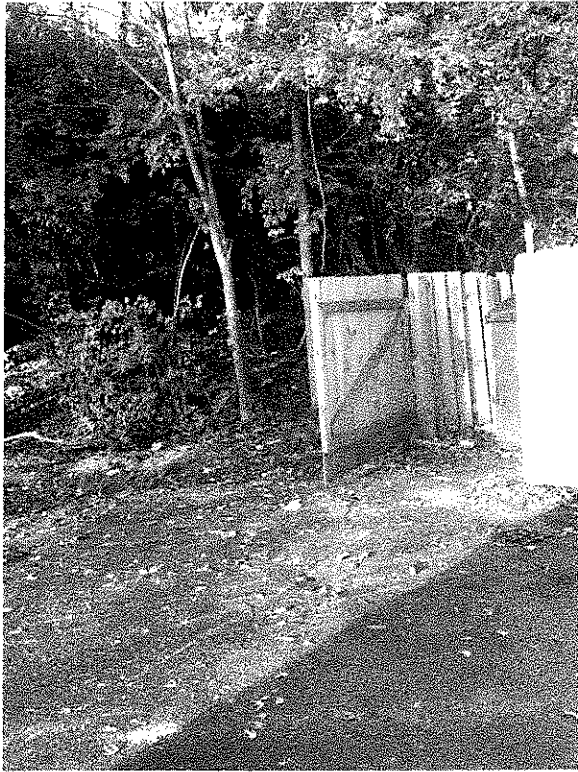
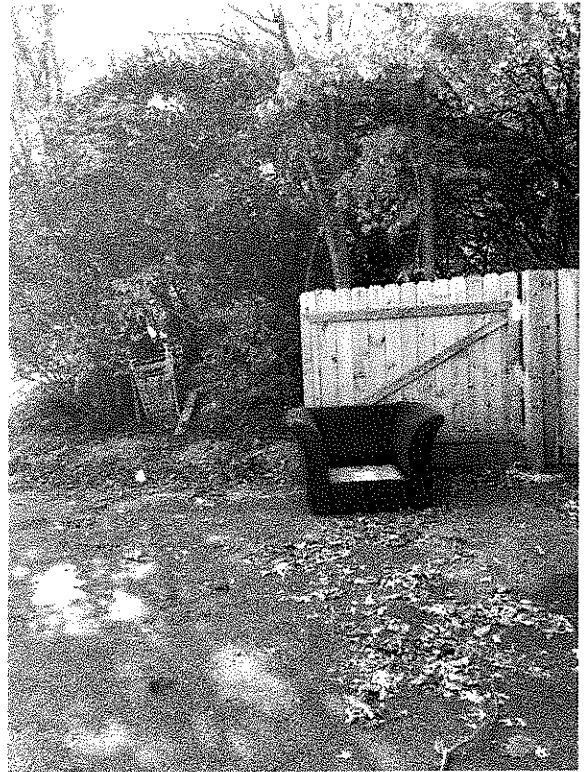
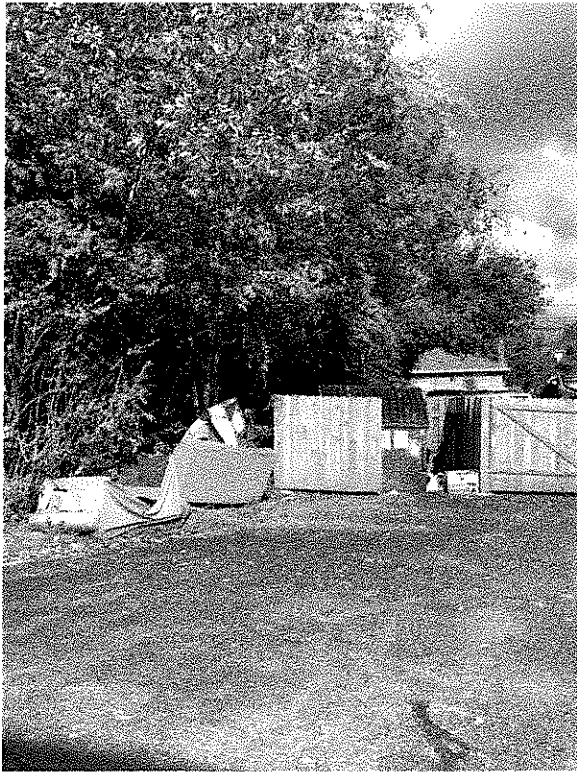
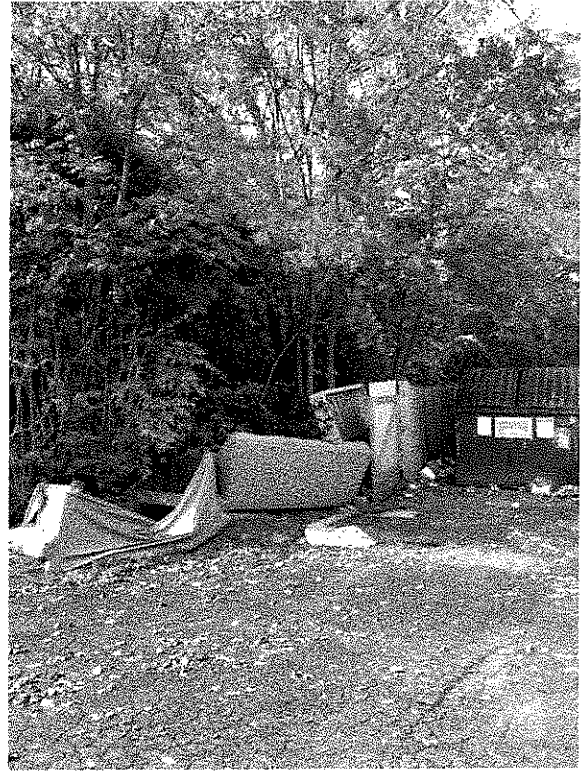
Trash has been removed
