# **EXHIBIT B**

1. December 17, 2021 Status Update with Photographs
2. December 23, 2021 Status Update with Attachments
3. Cole Engineering Report
4. January 2022 Status Update

**RE: Pine Lake Apartments Status Update**

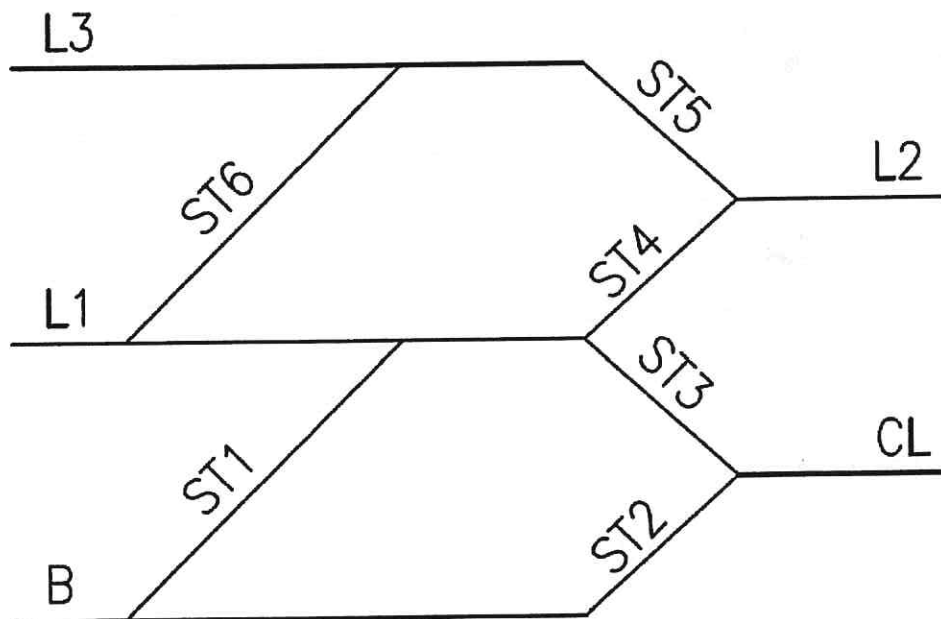
**Figure #1 (Stair Configuration #1)**

There are two separate stair configurations. In stair configuration one, there are three steel and concrete framed landings, one concrete landing supported by the ground, and six stairs, see Figure #1. In stair configuration two, there are three landings but only four stairs, see Figure #2.

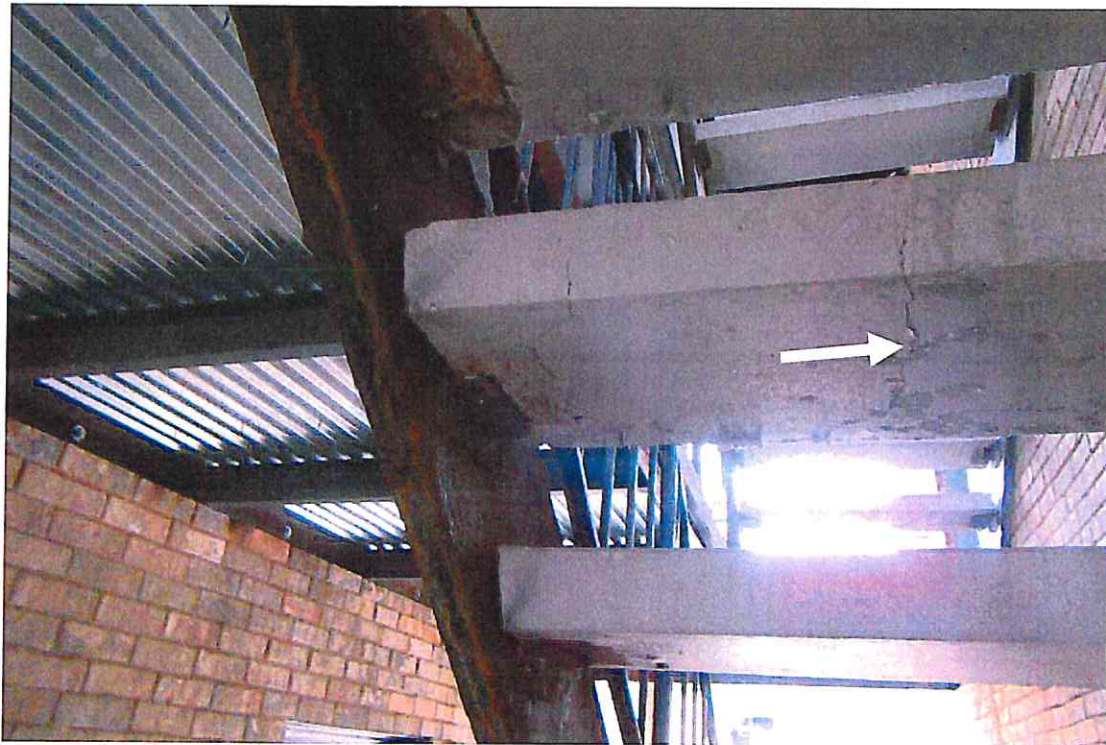
**PHOTO #2 (Unit #101)**

From a structural perspective, there are multiple treads which are structurally deficient and should be replaced, see photos #2 - #4. The exact locations along with their severity are marked in Appendix B. In addition to the structural issues, the majority of the treads are unevenly spaced in elevation. The building code requires that the difference between treads is not to be greater than 7 ¼” and that there is not more than a 3/8” variation between successive step surfaces. We found that these geometric provisions are not met by almost any of the stair stringers in this complex.

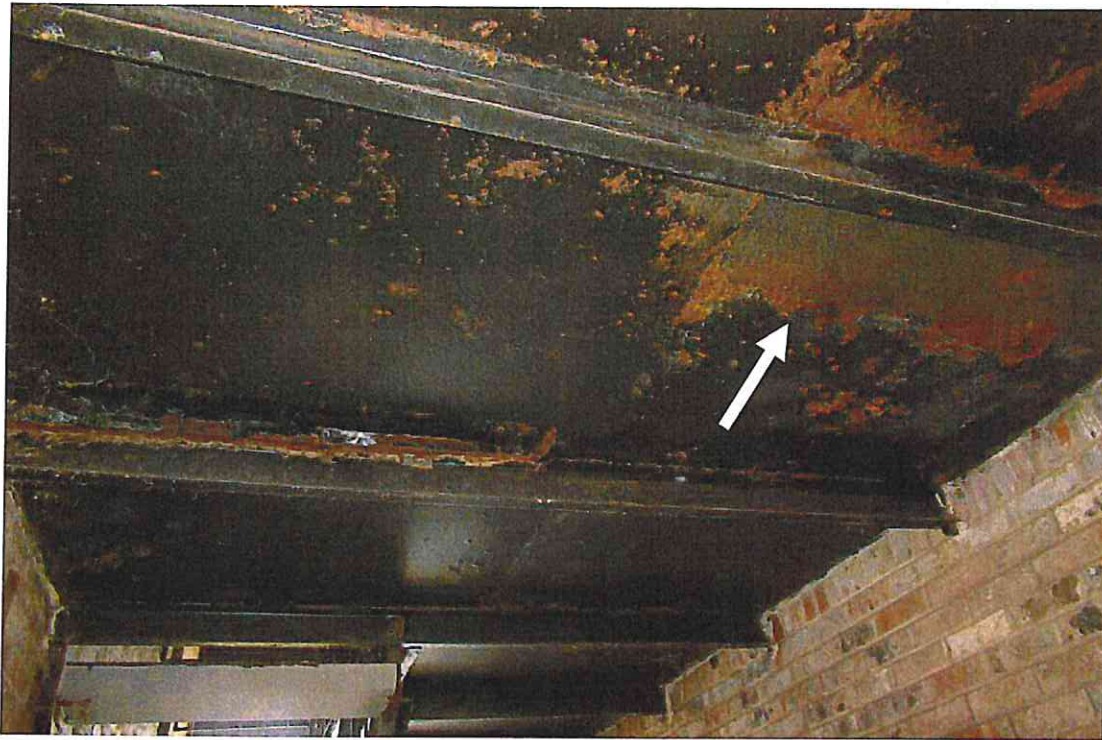
**PHOTO #5 (Unit #121)**

In the 2016 report we found that multiple landings were structurally deficient at that time and we recommended their replacement. We designed replacement landings and stair stringers. During our most recent visit we found that many of these had been replaced, but the structural sizes which we specified in our drawings were not used. Smaller sizes were used. These smaller sizes are structurally deficient as they do not have adequate strength to resist the forces mandated by the building code. Additionally, there are some landings with deteriorated members which we rank as “dangerous” at units #121, #125, #7153, and #7959. These range from metal plates which are peeling off the bottom and are about to fall to connections at the walls which are in the process of collapse. See photos #5 - #8 for some examples of deficient areas.

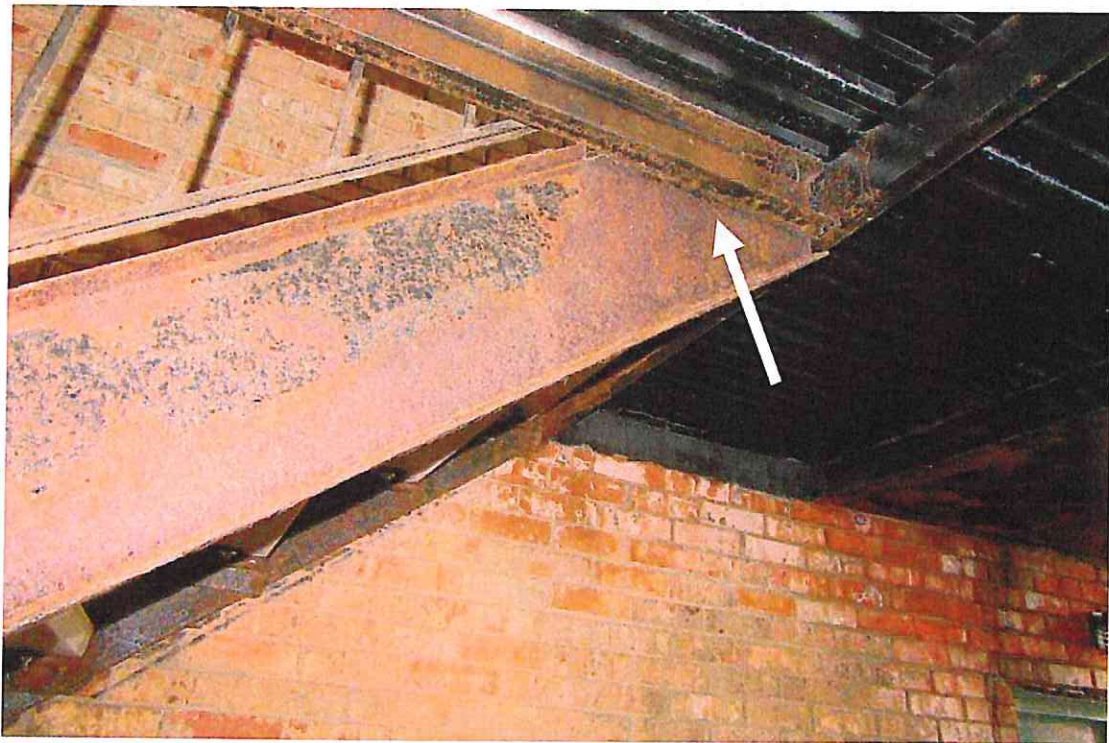
**PHOTO #10 (Unit #7959)**

At multiple locations the steel stringers are heavily rusted. Units #125 and #7959 have stringers which we classified as “dangerous”, see photos #9 - #11.
